U.S. Firefighter Disorientation Study

1979 - 2001

**Prepared by
William R. Mora, Captain
San Antonio Fire Department
San Antonio, Texas**

July 2003

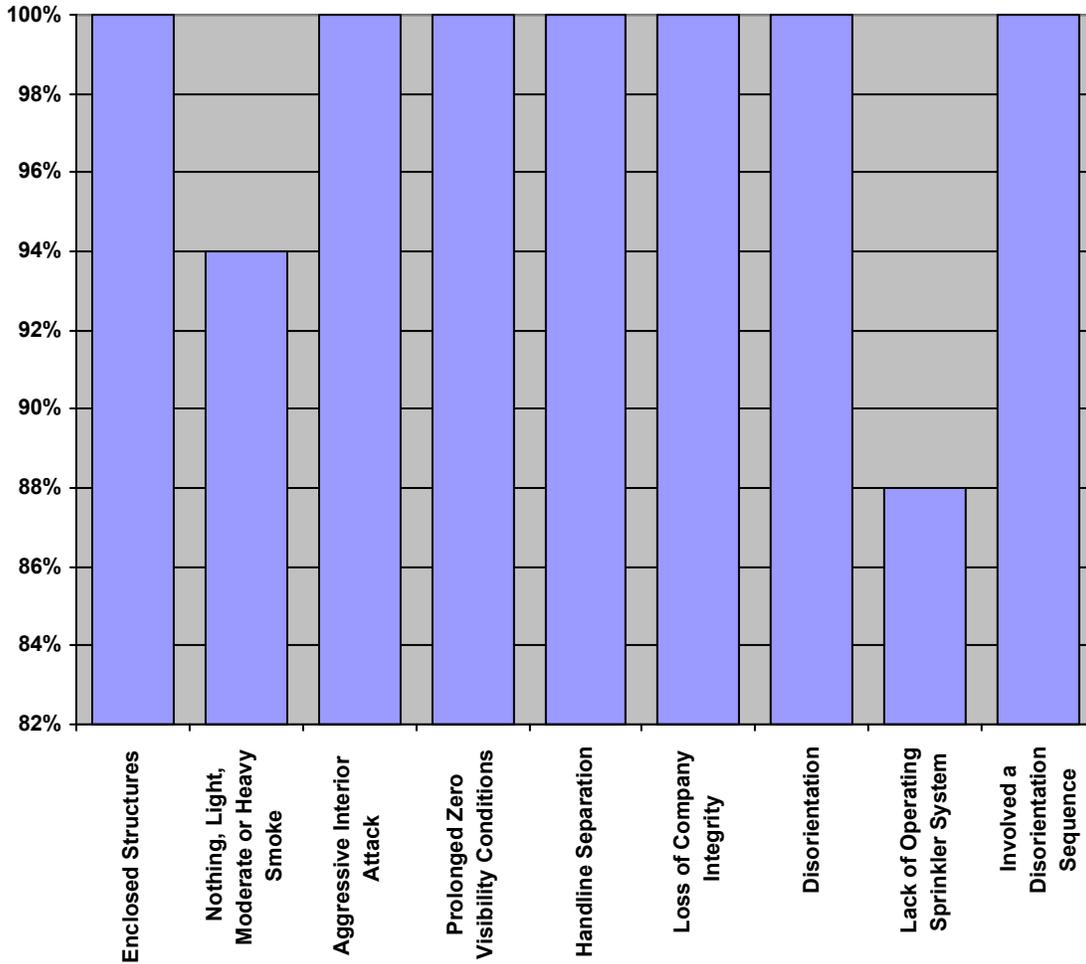
Figure 1

There were nine major similarities involving each of the structures and fireground operations. These areas of similarities appear in the graph in figure 1. Of the 17 national incidents studied:

1. 100% occurred in an enclosed structure.
2. 94% had nothing, light, moderate or heavy smoke showing on arrival
3. 100% utilized an aggressive interior attack
4. 100% developed prolonged zero visibility conditions
5. 100% experienced handline separation or tangled handlines
6. 100% experienced loss of company integrity
7. 100% experienced disorientation
8. 88% lacked a functioning sprinkler system
9. 100% involved a disorientation sequence

SIMILARITIES IN DISORIENTATION FIRES
