# Best Practices for Emergency Response to Incidents Involving Electric Vehicles Battery Hazards: A Report on Full-Scale Testing Results

*Final Report*

Exponent, Inc.  
17000 Science Drive, Suite 200  
Bowie, MD 20715

© June 2013 Fire Protection Research Foundation

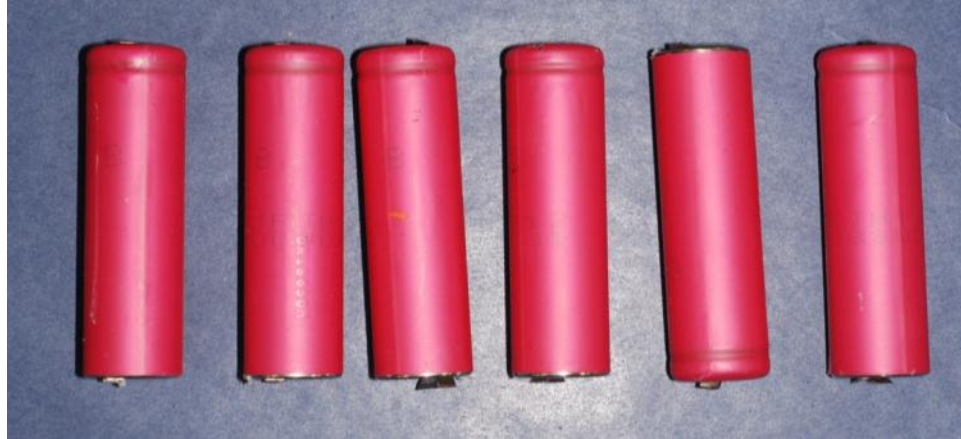
Figure 3 Example of 18650 cylindrical cells (these are the most common consumer electronics Li-ion cell form factor)

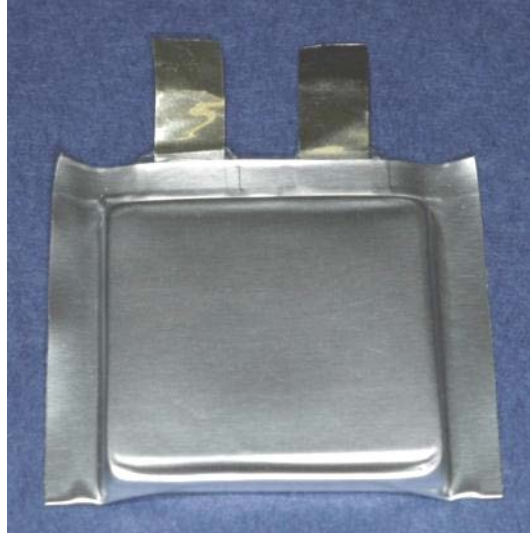
Figure 5 Example of a soft-pouch polymer cell

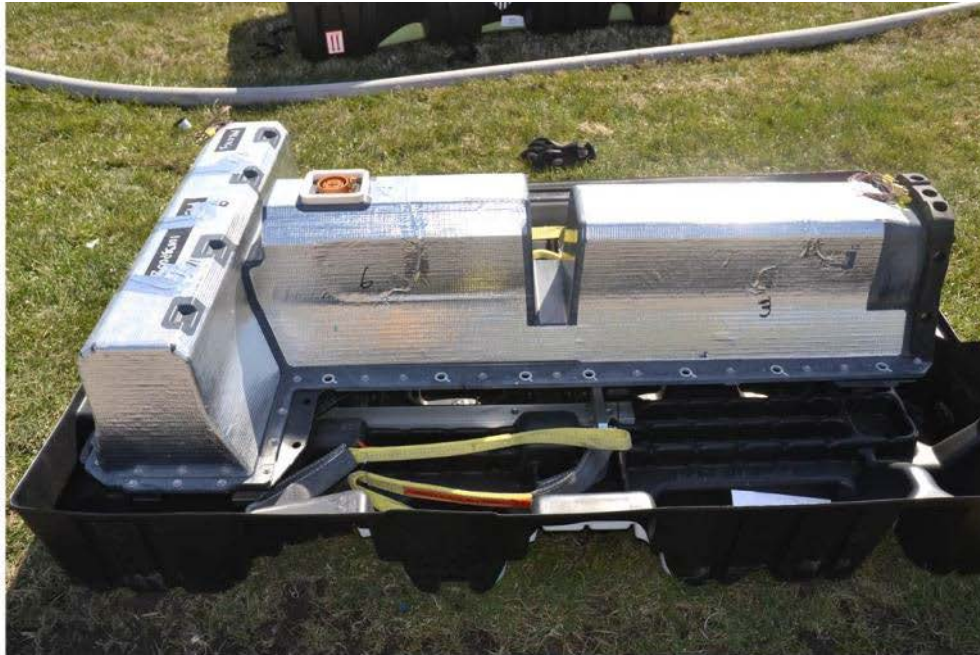
Figure 9 Battery B

Battery B is designed for an EREV and features a battery assembly that contains sealed Li-ion battery cells. The 16 kWh battery pack sits on top of a steel plate and is enclosed in a fiberglass case, as shown in Figure 9. The T-shaped battery spans nearly the length of the vehicle from the rear axle to the front axle and is rigidly mounted underneath the vehicle floor pan, as shown in Figure 10. A vehicle passenger compartment floor pan separates the battery assembly from the passenger compartment. The electrolyte used in the Li-ion battery cells is a flammable organic electrolyte.

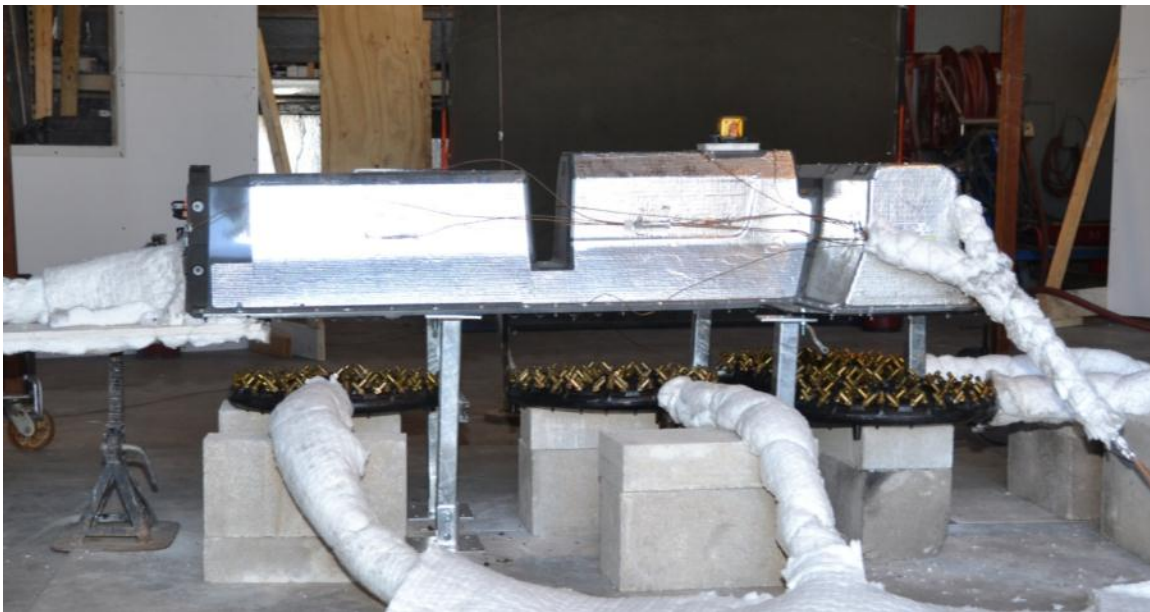
Figure 11 Battery B configuration and burner locations for HRR testing

Battery B was centered under a 20 foot by 20 foot hood supported by five stainless steel legs, as shown in Figure 11 and Figure 12. The leg supports held the battery in place, twenty inches above the ground to provide a viewing angle to the bottom of the battery during testing.

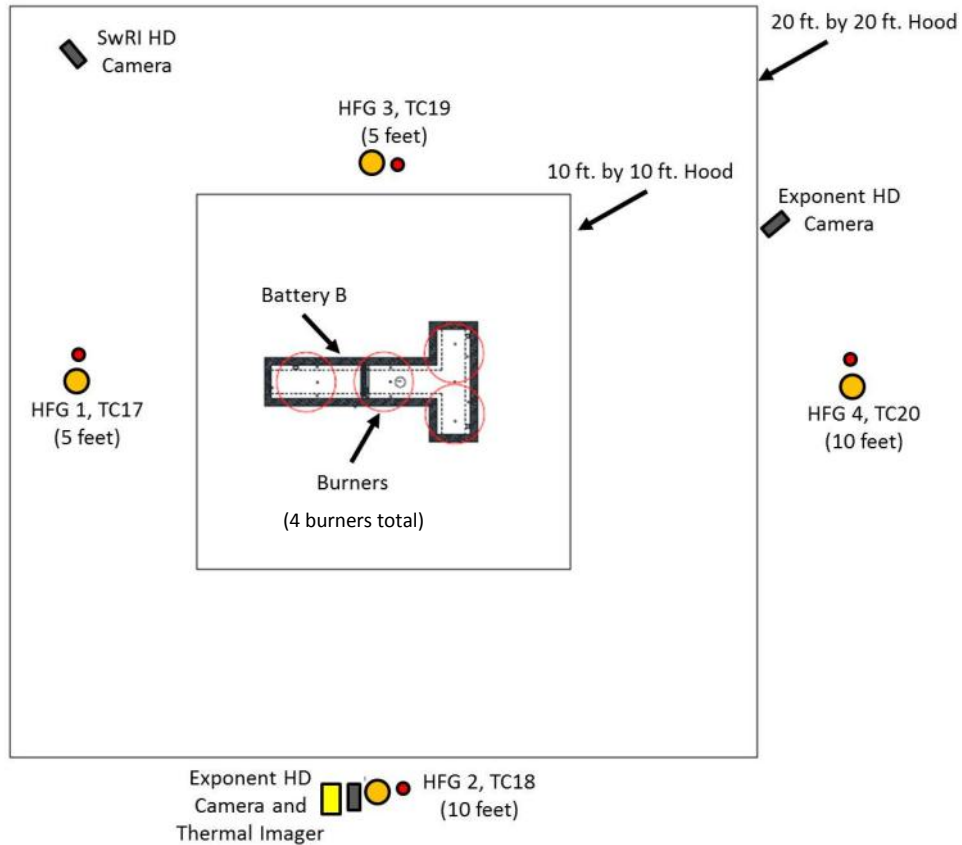
Figure 12 Layout and arrangement of the HRR testing perimeter instrumentation

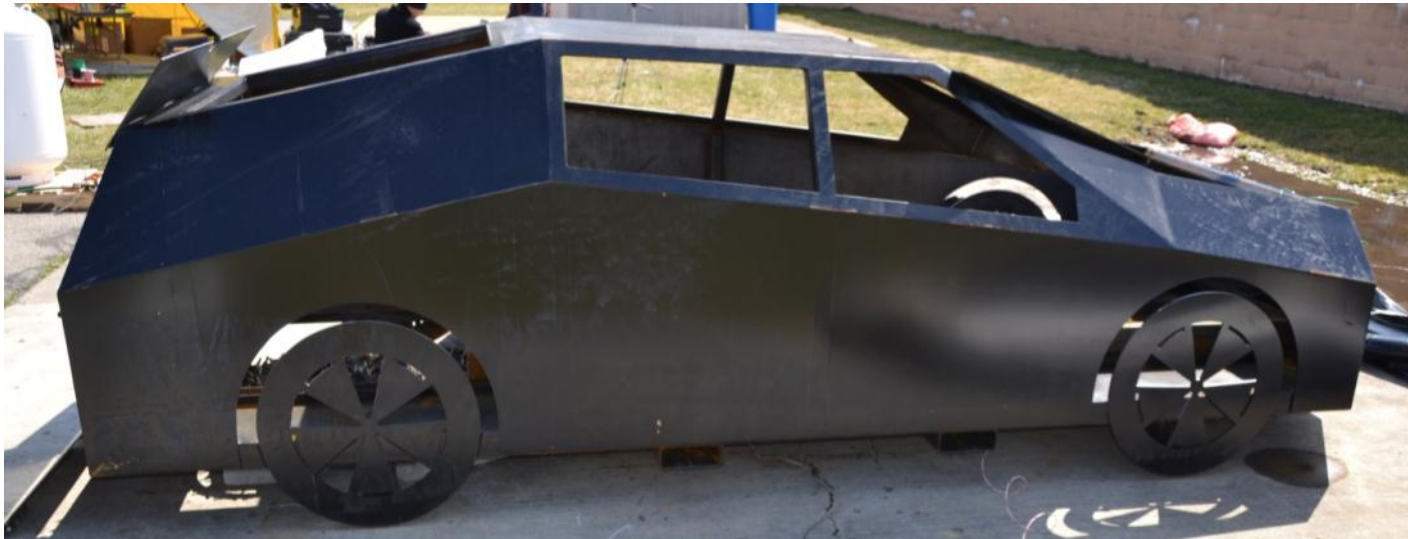
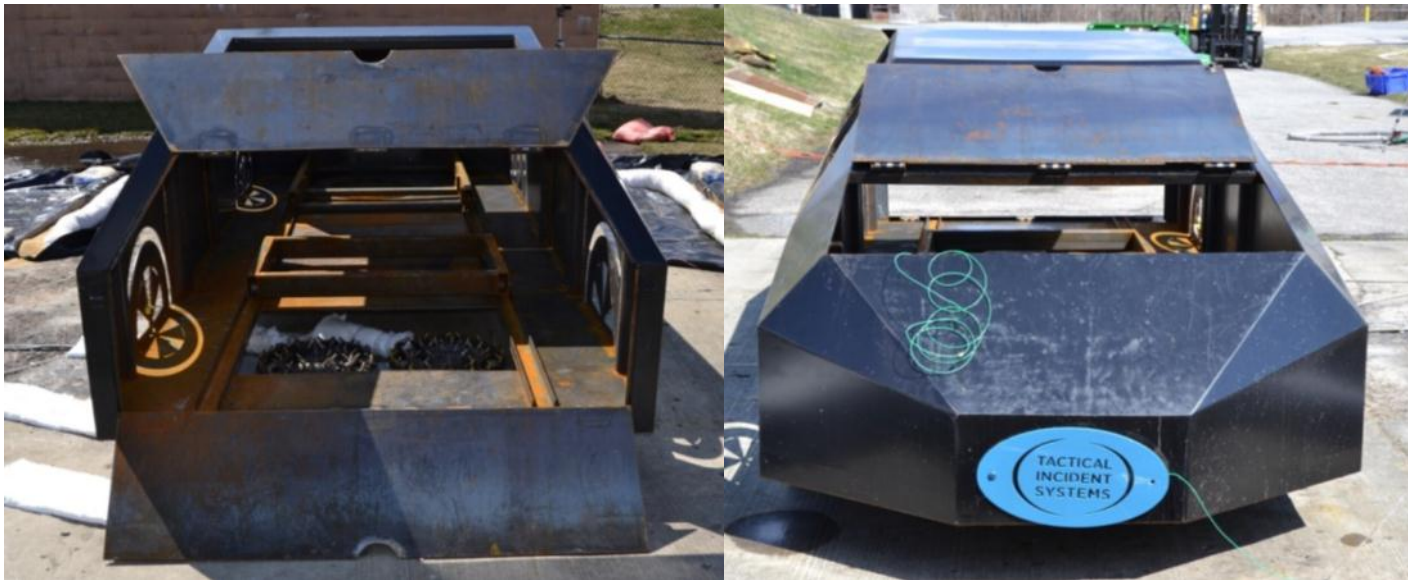
Figure 24 VFT: Side profile (top); rear profile with hatchback open (bottom left); and front profile with hood open (bottom right)

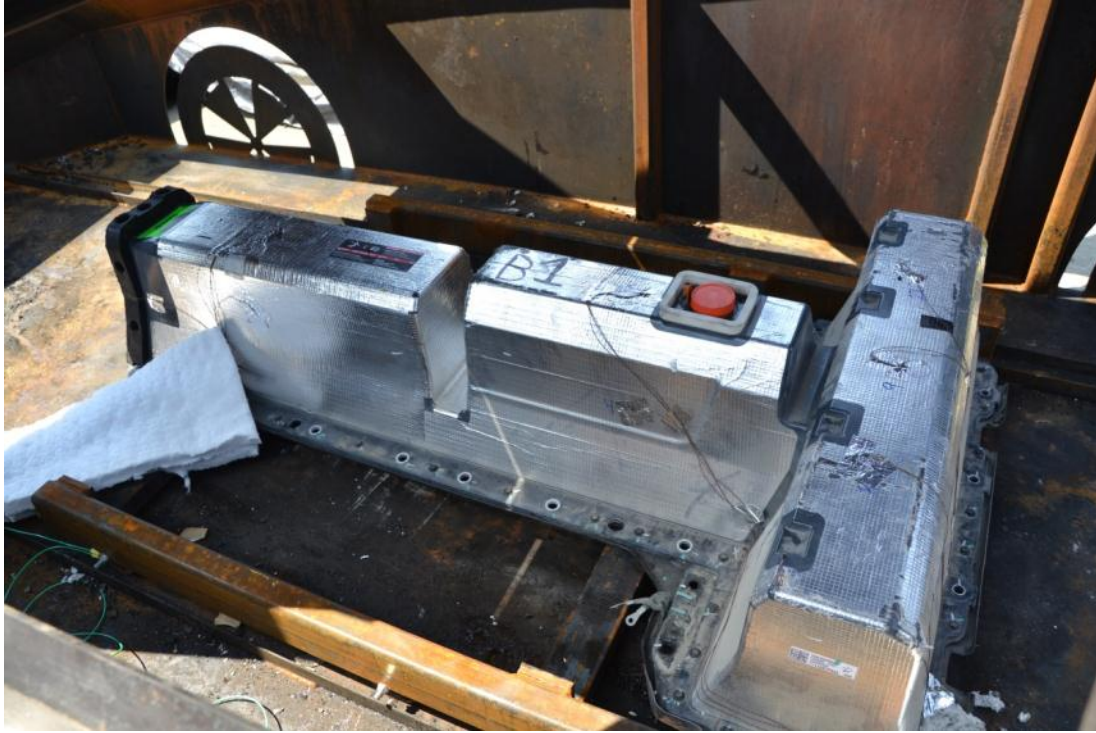
Figure 27 Battery B positioned on the carriage above the burners inside the VFT; burners located in the center test position

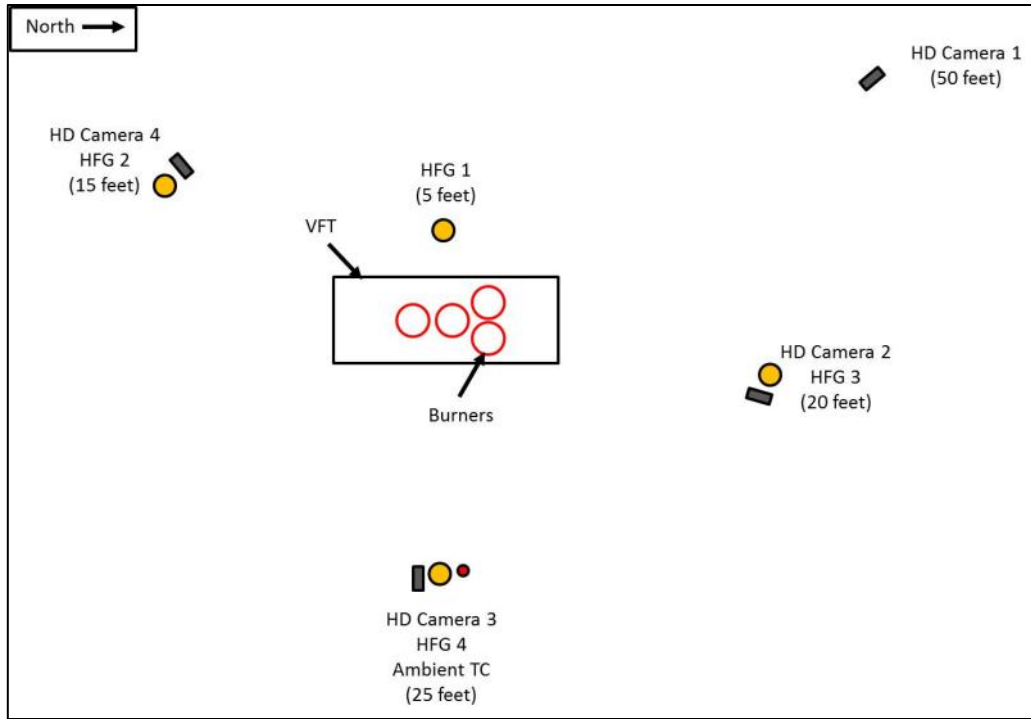
Figure 28 Layout and arrangement of the suppression testing perimeter instrumentation

The VFT was placed on a concrete burn pad at MFRI, as shown in Figure 28. The burners slid under the VFT and into position depending on the battery type and had direct access to the bottom of the batteries through the holes cut out in the VFT floor pan. For Battery A, the four burners were centered six inches under the rectangular battery, as shown in Figure 25 and Figure 26. For the first two tests, Tests A1 and A2, the battery was installed alone within the VFT, as shown previously in Figure 26. For test A3, typical interior finishes/upholstery, including car seats, a dashboard, and a carpet layer above the battery (used to separate the battery from the cargo compartment) were also installed within the VFT, as shown in Figure 29 through Figure 33. The car interiors were procured from vehicles that were of a similar size as the VFT. These additional vehicle interior finishes were installed to better simulate the fuel load of a typical vehicle.

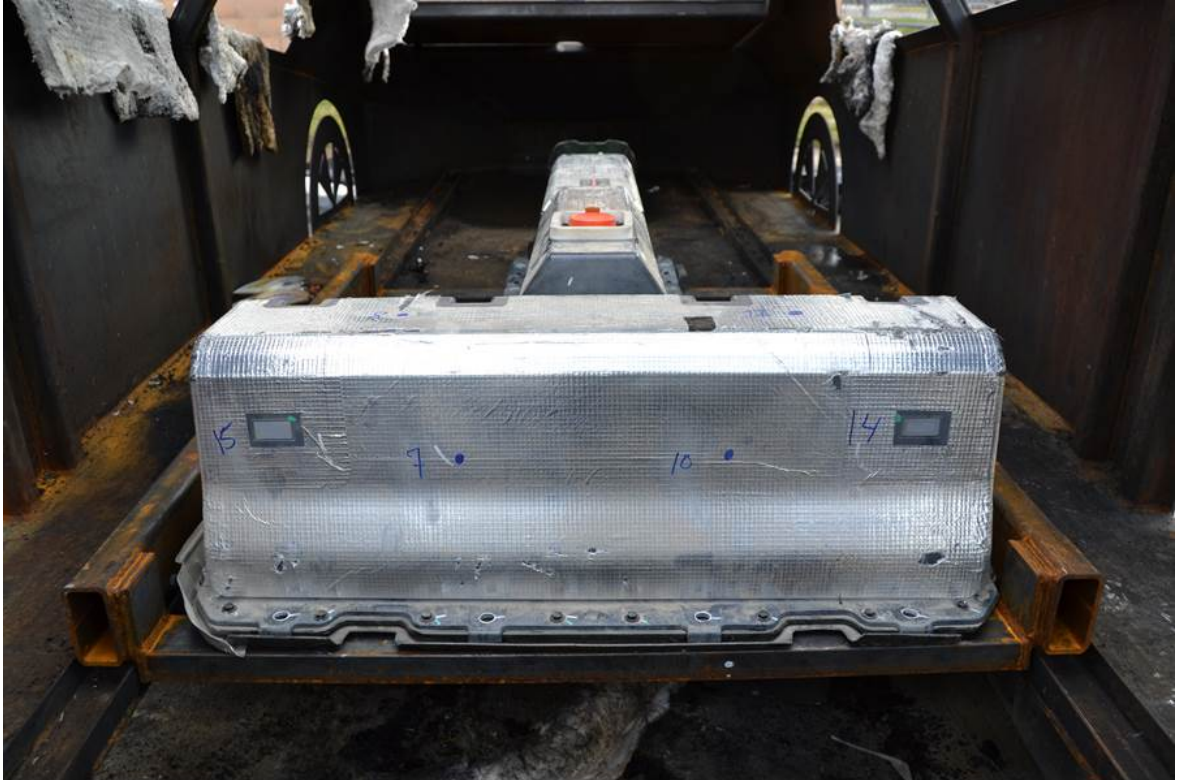
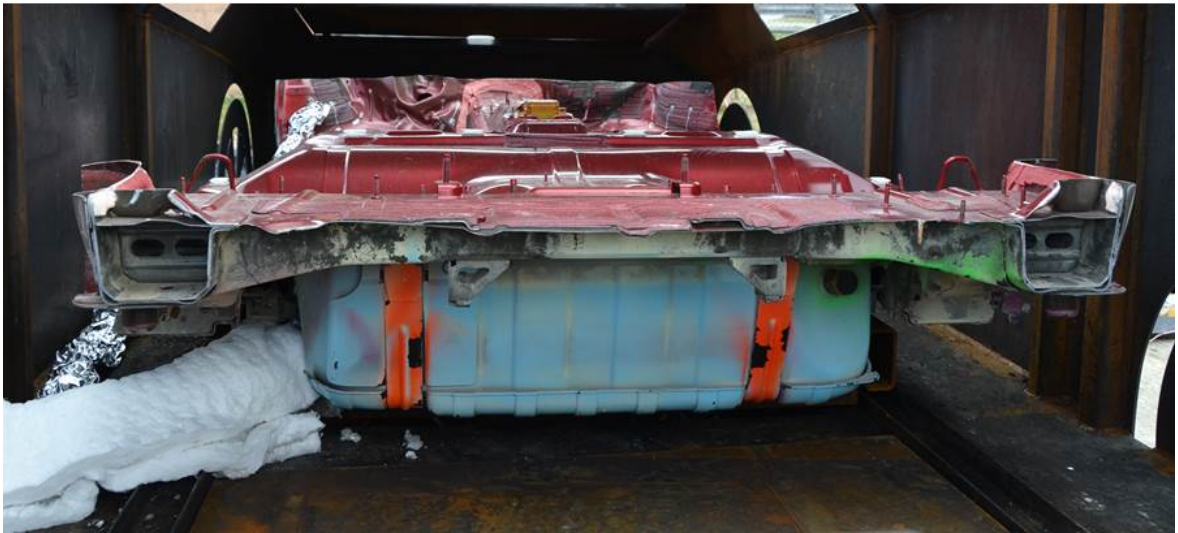
Figure 34 View of Battery B inside the VFT without the floor pan (top) and with the floor pan (bottom); the blue tank at the rear of the battery is the empty gasoline tank for the production vehicle, which blocks direct access to the rear of the battery

For Battery B, the four burners were positioned under the span of the T-shaped battery to provide a uniform heat source to the entire battery pack, as described in Section 5.1.2 for the HRR test. Inside its production vehicle, a steel floor pan is positioned on top of the battery, separating it from the passenger compartment. As such, the vehicle manufacturer that donated Battery B also donated a steel floor pan from an actual vehicle to be placed above the battery during testing. This configuration provided a more realistic vehicle fire scenario, as shown in Figure 34 and Figure 35. For the first two tests, Tests B1 and B2, the battery and the steel floor pan were installed within the VFT. For Test B3, typical interior finishes/upholstery, including car seats, a dashboard, and carpeting were added to the VFT along with the battery and steel floor pan, as shown in Figure 36 through Figure 40. The car interiors were procured from vehicles of a similar size to the VFT. These additional vehicle interior finishes were installed to better simulate the typical fuel load expected in a vehicle fire.

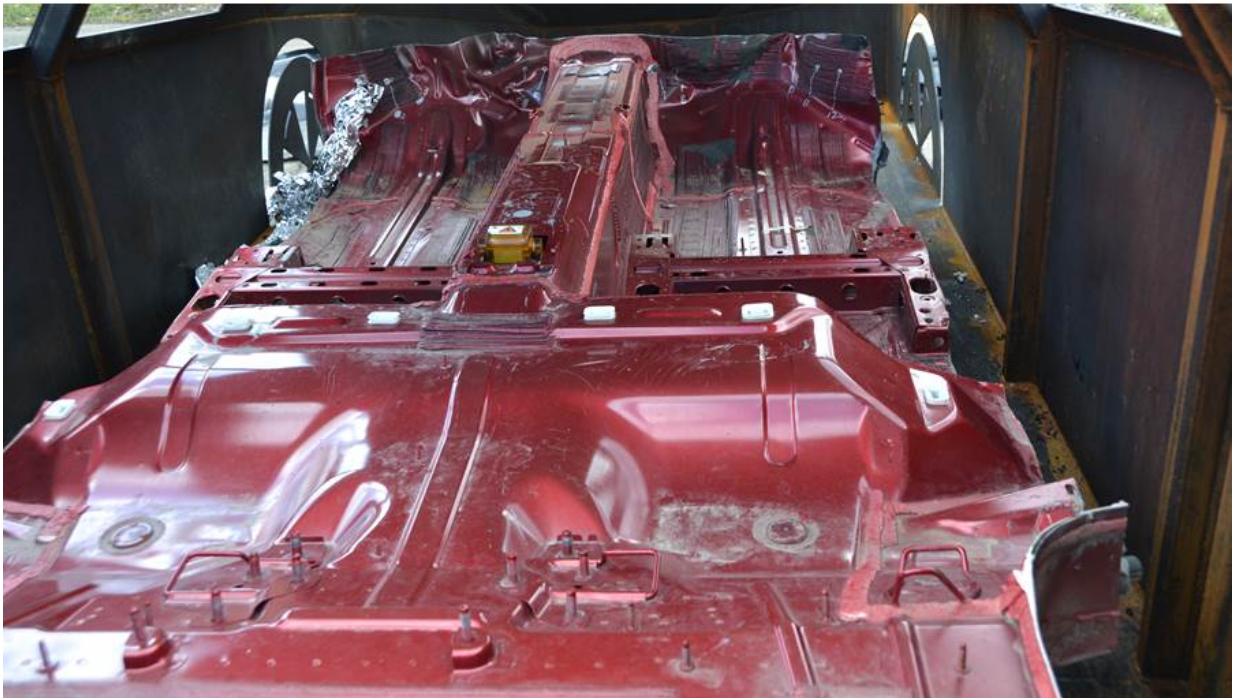
Figure 35 Top view of Battery B inside the VFT without the floor pan (top) and with the floor pan (bottom); the yellow fuse in the middle of the red floor pan is the only hole within the pan that allows for access to the battery

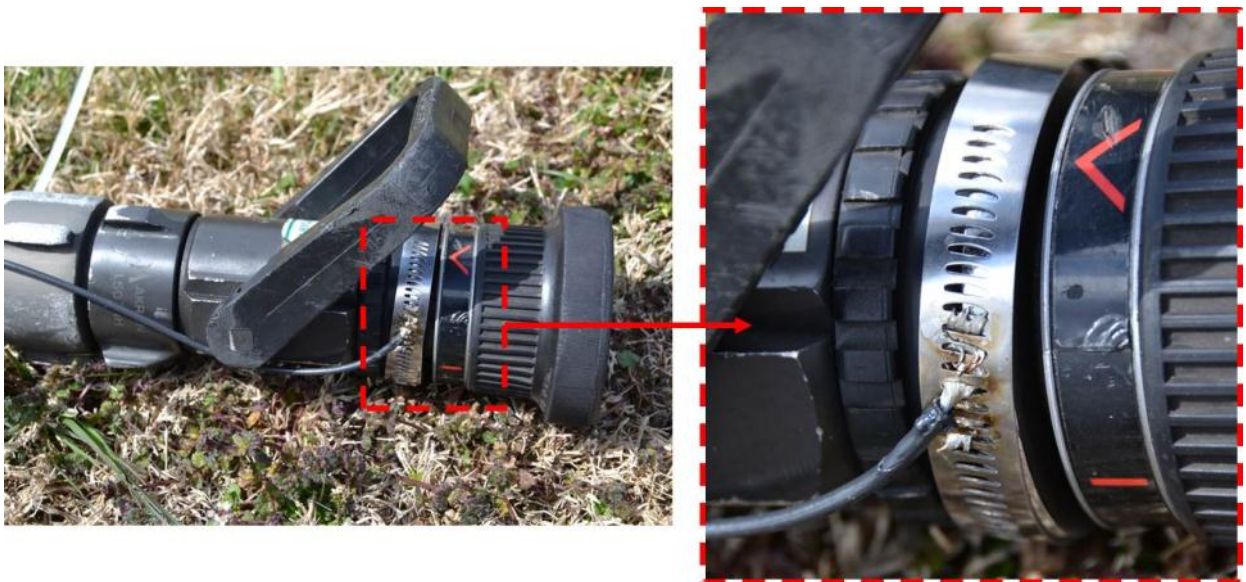
Figure 41 14 AWG stranded copper wire soldered to a hose clamp and affixed to the nozzle's exterior housing

battery was placed were also measured. For the electrical measurements at the nozzle, 14 AWG stranded copper wire was securely soldered to a hose clamp and affixed to the nozzle's exterior housing, as shown in Figure 41. Continuity tests confirmed that the front of the nozzle from which water was expelled was electrically connected to the discharge portion of the nozzle. The wire was then routed back to the DAQ system utilized to collect the voltage and current measurements, as shown in Figure 42. Similarly, at the chassis, a separate 14 AWG stranded copper wire was securely connected to the body of the chassis and run along the ground to the DAQ system, where it was connected to the measurement circuit shown in Figure 42. Inside the chassis, additional metallic components, such as the sliding chassis and the VFT body components were also connected using a 14 AWG stranded copper wire to the same measurement wire such that all conductive items, including the sliding chassis and the VFT body components, were electrically connected. Due to the high temperatures expected inside the VFT, the internal wires were protected using aluminum foil and Kaowool. Though in most tests the wire insulation nearest the most intense portion of the fire was found to be degraded in post-test assessment, continuity after each test was confirmed to verify all conducting objects in the chassis remained electrically connected throughout the test.

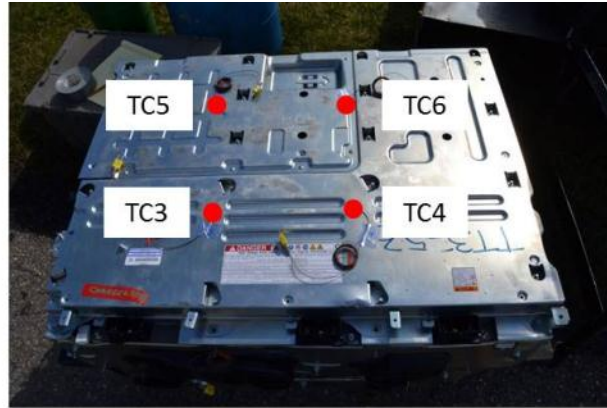
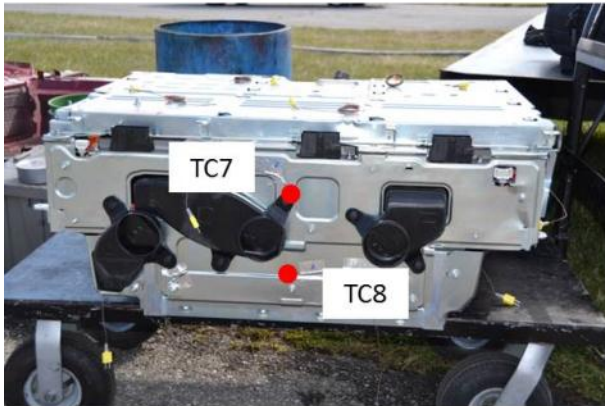
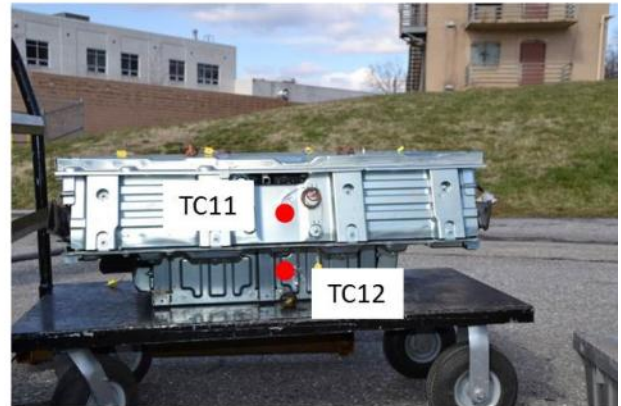
Figure 44 TC locations (red circles) on battery exterior for Battery A tests
