6.2.4 Battery B1 Test

6.2.4.1 Test Observations

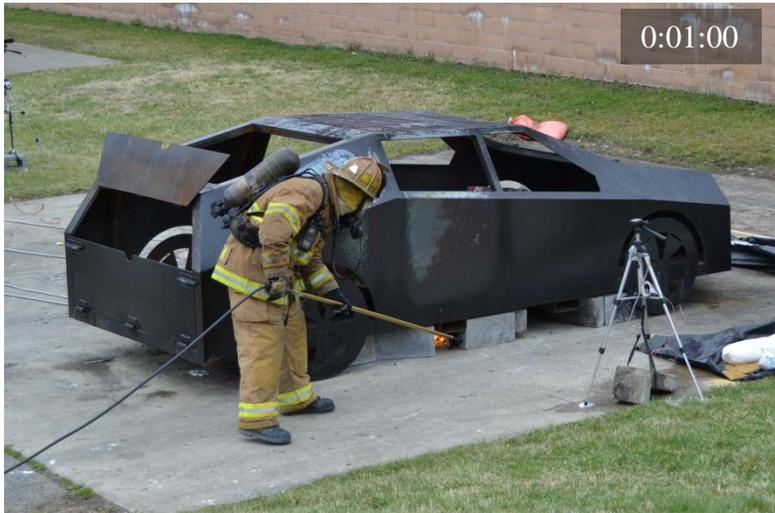
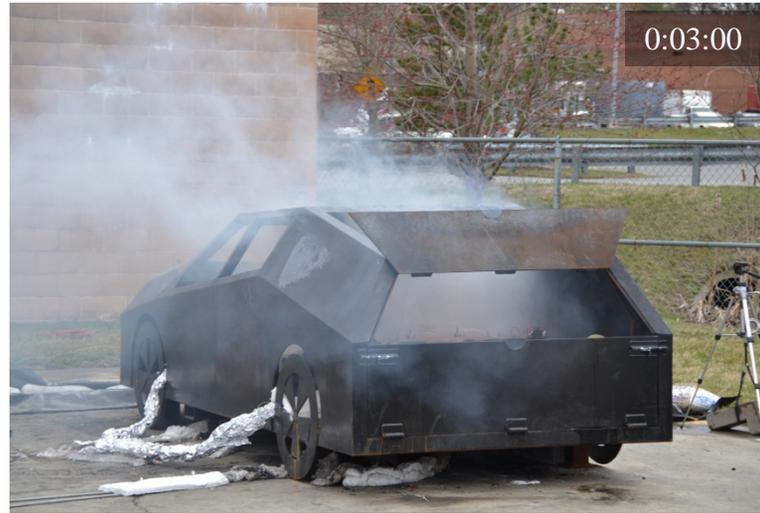
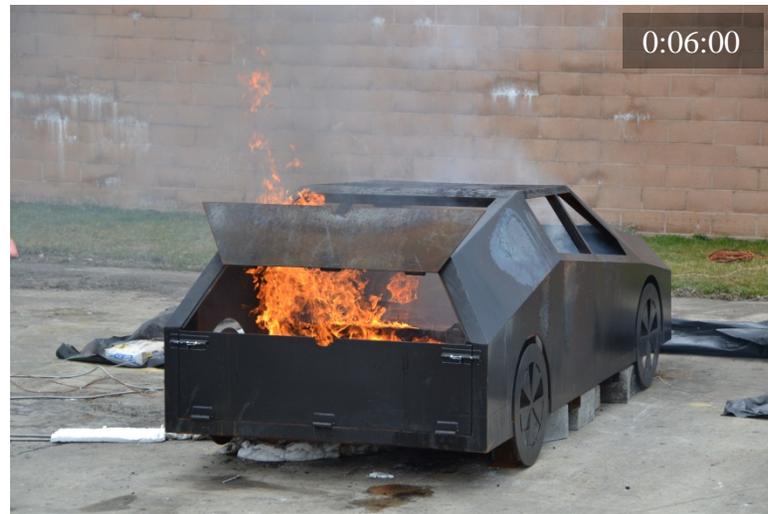
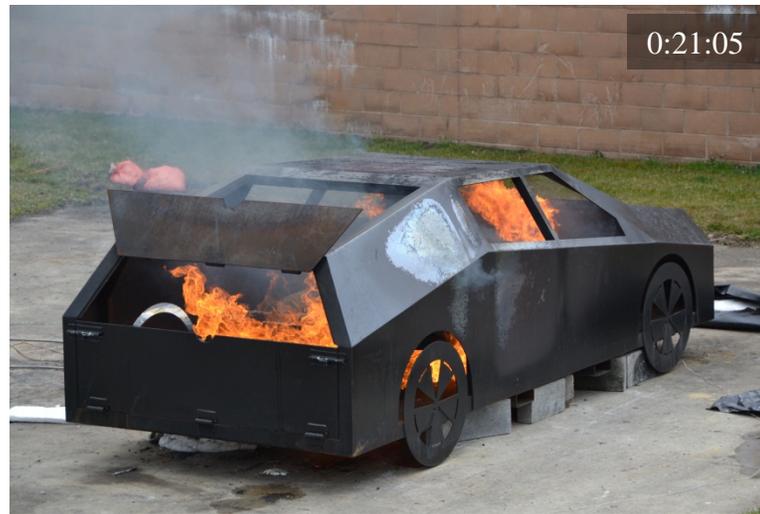
Figure 74 Test B1: ignition (top left); off gassing (top right); fully involved (bottom left); burners off (bottom right)

Table 29 summarizes the key events observed by Exponent staff during Test B1. Images at significant test times are provided in Figure 74 and Figure 75. In general, the test demonstrated that an external heat source could induce Battery B into thermal runaway while it was positioned inside a VFT and result in the visible release and ignition of electrolyte material. Loud popping sounds from the interior of the battery were heard and visible sparks were observed on many occasions. White smoke and off gassing were observed steadily throughout the test and were consistent with the release of flammable electrolyte material. However, no projectiles, explosions, or bursts were observed during the test while the battery was exposed to the burners, while it was in a free burn state, while it was being suppressed, or after suppression efforts ceased.

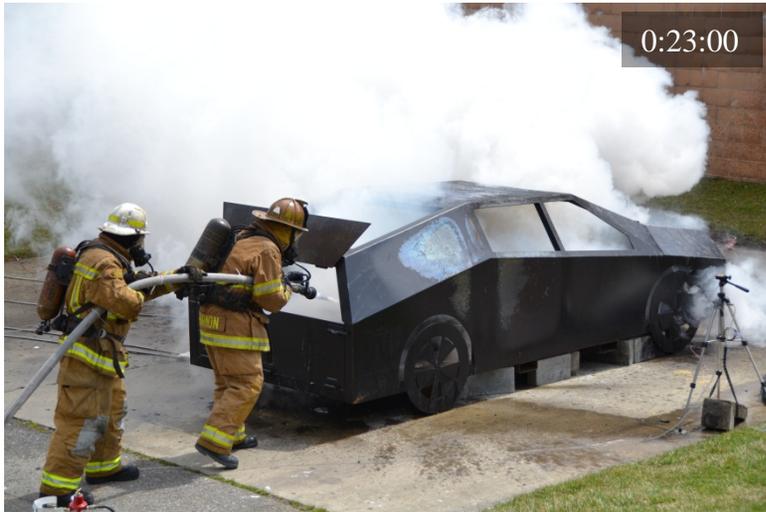
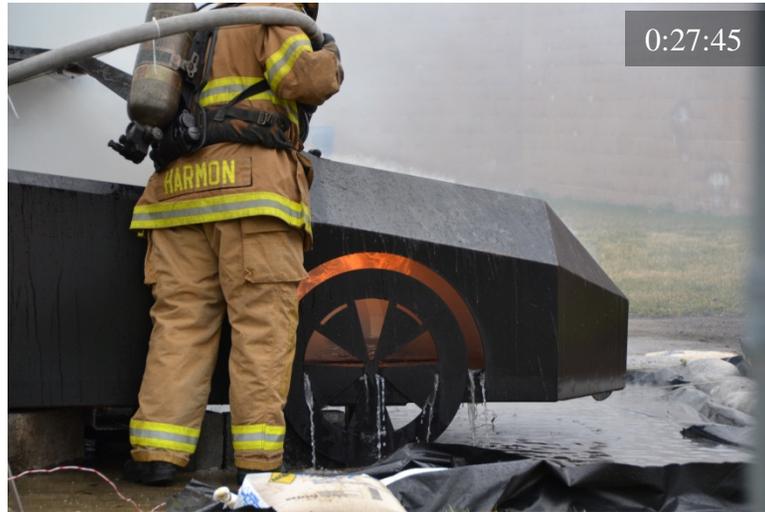
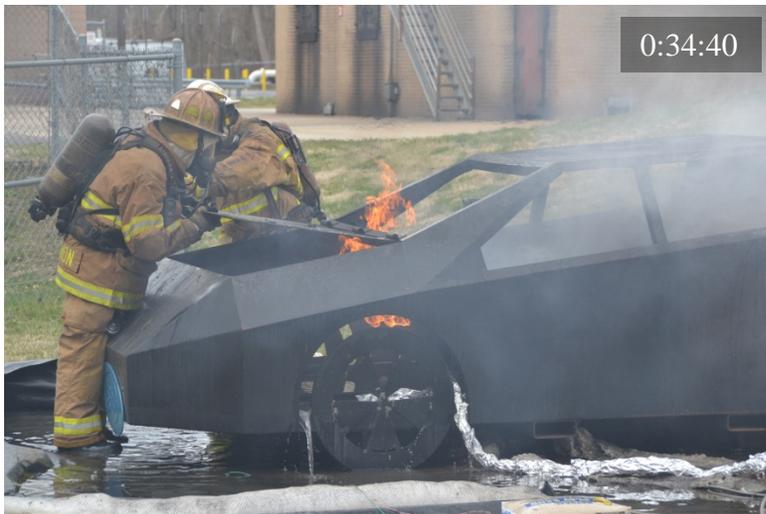
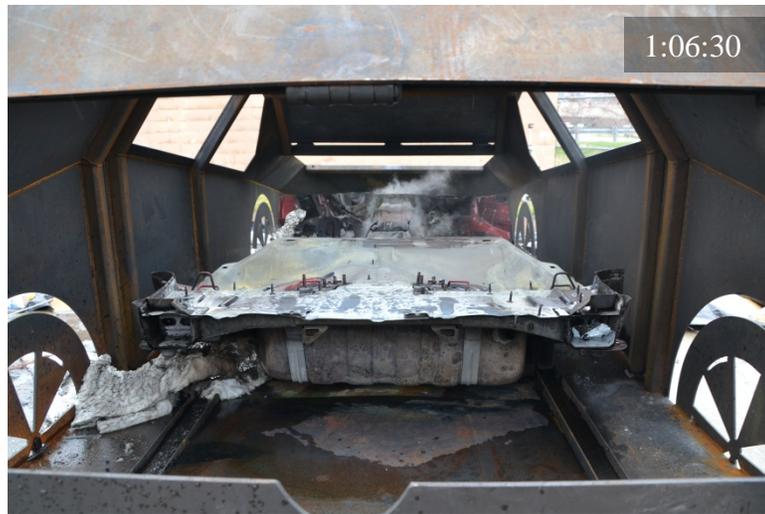
Figure 75 Test B1: suppression starts (top left); reignition and suppression (top right, bottom left); post suppression (bottom right)

Once suppression started, the firefighters were constantly applying water to the battery fire attempting to control the flames. The initial battery fire was not immediately knocked down, as the firefighters were more or less consistently applying water to the battery with only short breaks (10 to 20 seconds) between each water application to reposition themselves or while waiting for the battery to reignite. Active suppression efforts ceased approximately 26 minutes after the first application of water. Once the battery fire was under control, it continued to smoke and off gas for several hours afterwards, although no reignition was observed. External temperatures on the battery casing did not decrease to near ambient levels until nearly four hours after the test started and internal battery temperatures did not reach ambient temperatures until nearly 12 hours after the test started. See Sections 6.2.4.2 and 6.2.4.3 for more details on the firefighting efforts and Section 6.2.4.7 for more details on overhaul operations.

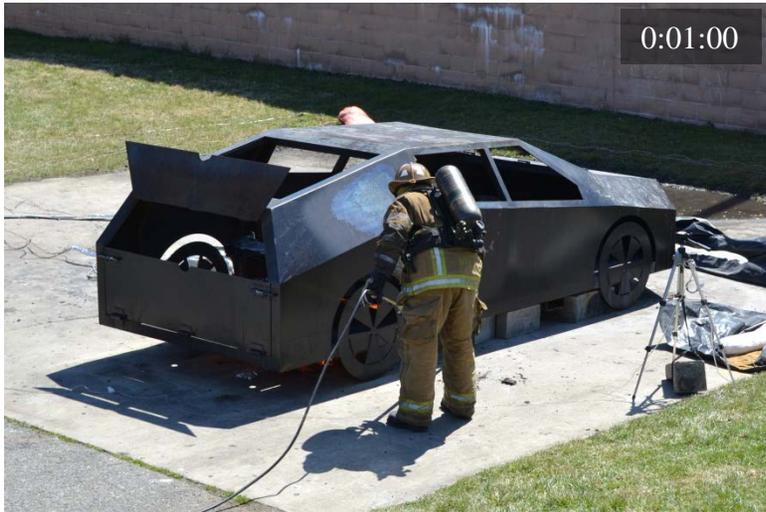
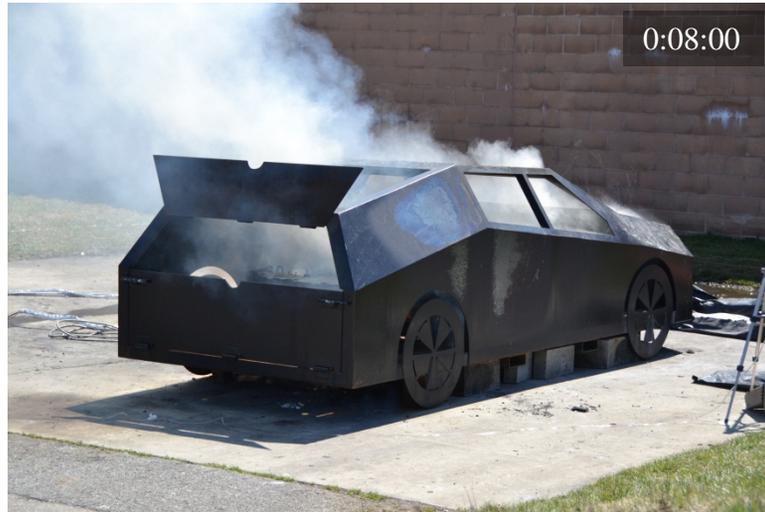
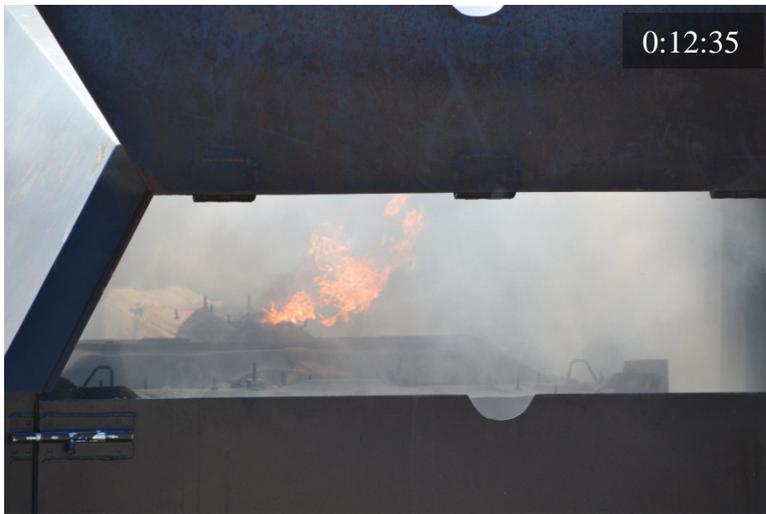
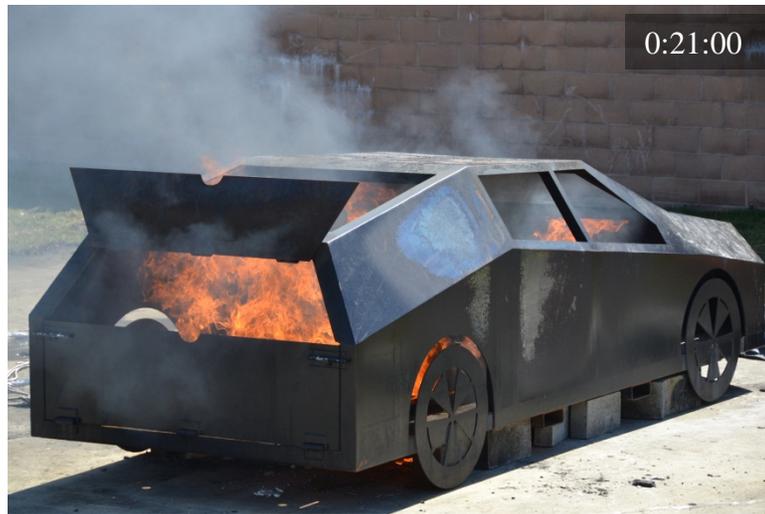
Figure 80 Test B2: ignition (top left); off gassing (top right); flames from fuse (bottom left); burners off (bottom right)

Table 35 summarizes the key events observed by Exponent staff during Test B2. Images at significant test times are provided in Figure 80 and Figure 81. In general, the test demonstrated a similar fire scenario seen in Test B1. Loud popping sounds from the interior of the battery were heard and visible sparks were observed on multiple occasions. White smoke and off gassing were observed steadily throughout the test consistent with the release of electrolyte material. However, no projectiles, explosions, or bursts were observed during the test while the battery was exposed to the burners, while it was in a free burn state, while it was being suppressed, or after suppression efforts ceased.

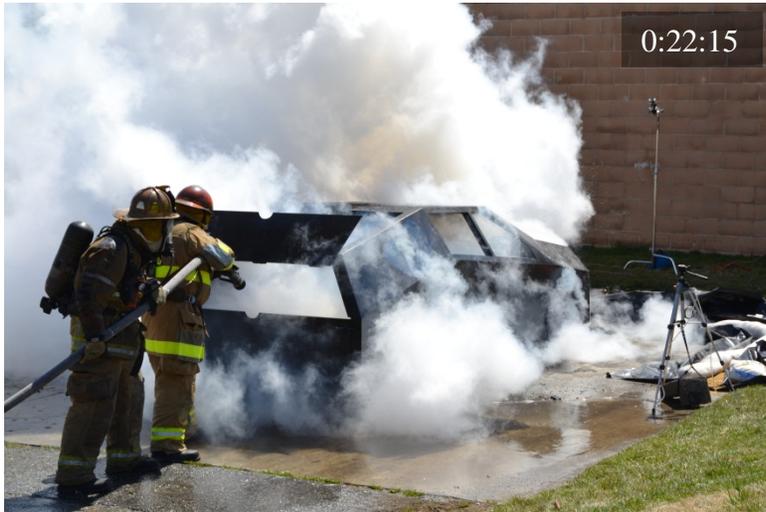
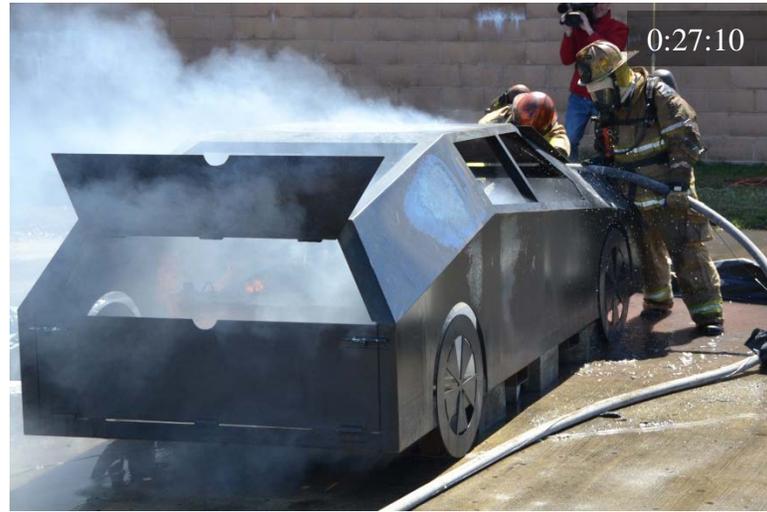
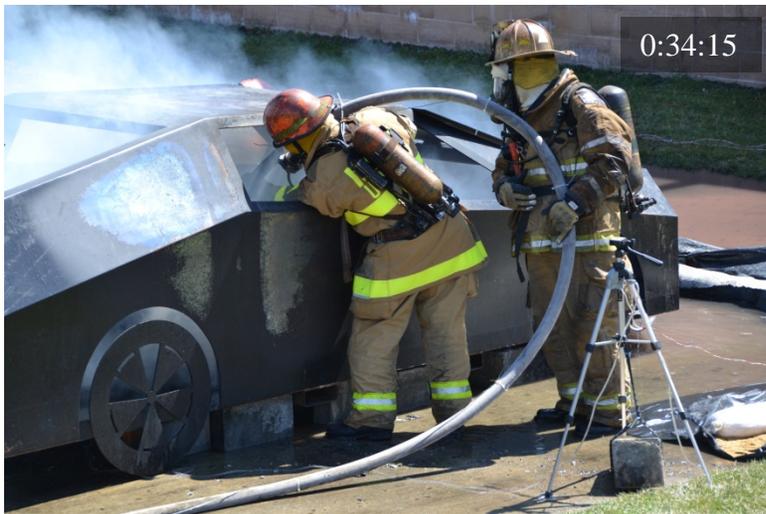
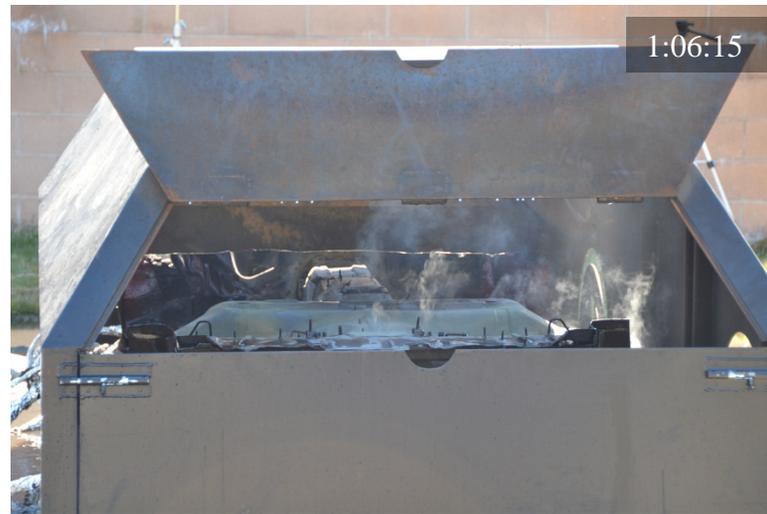
Figure 81 Test B2: suppression starts (top left); reignition and suppression (top right, bottom left); post suppression (bottom right)

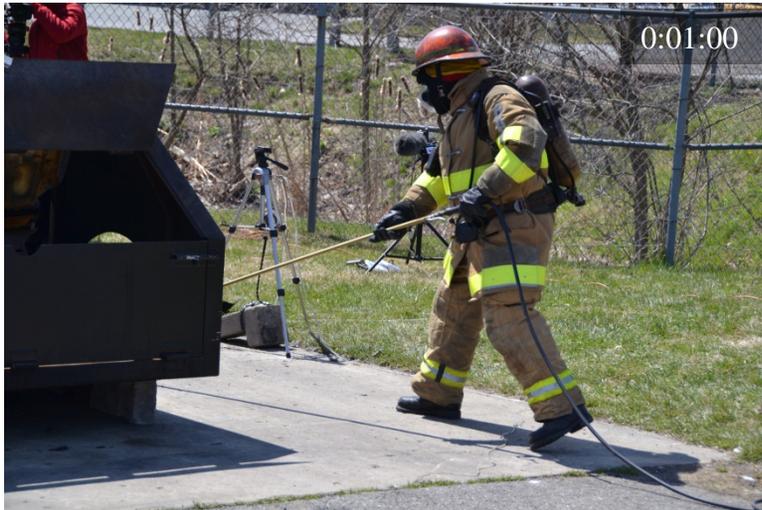
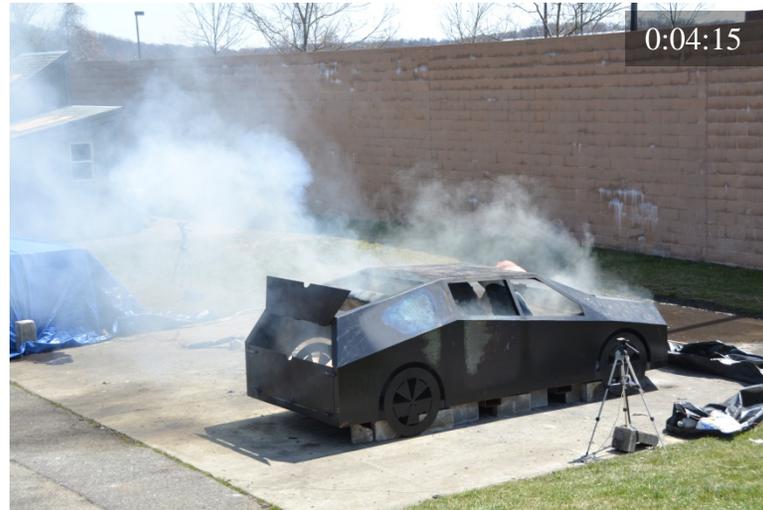
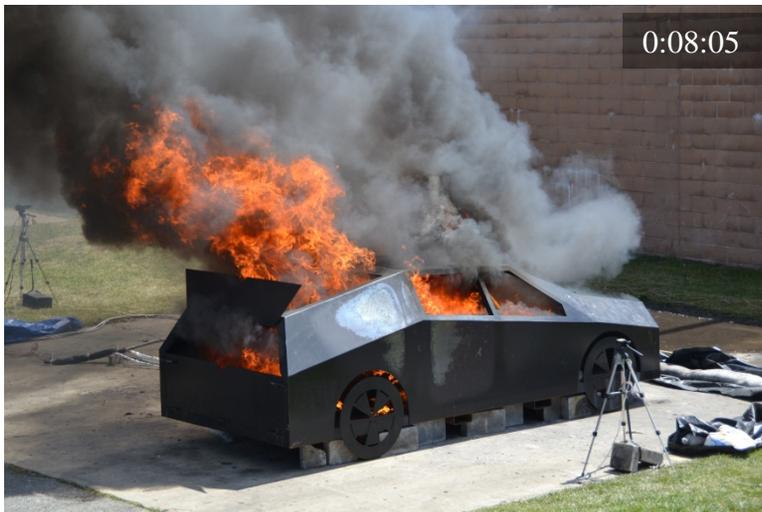
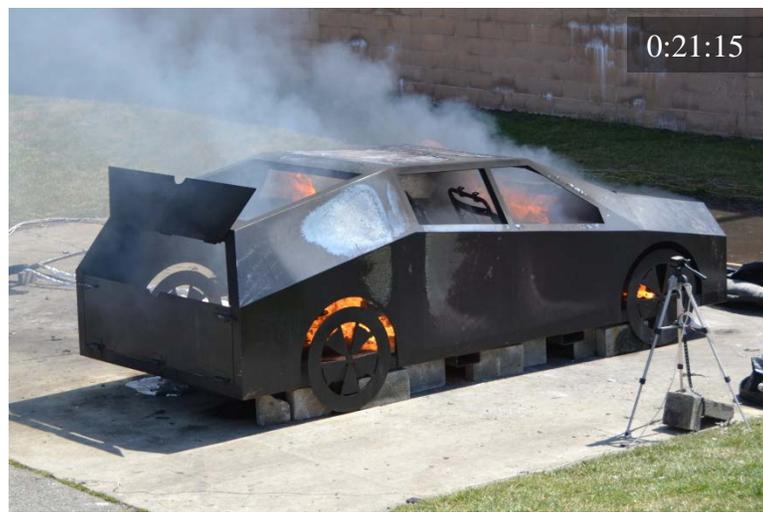
Figure 88 Test B3: ignition (top left); off gassing (top right); fully involved (bottom left); burners off (bottom right)

Table 41 summarizes the key events observed by Exponent staff during Test B3. Images at significant test times are provided in Figure 88 and Figure 89. In general, the test demonstrated a more severe fire scenario than seen in Tests B1 and B2 due to the additional interior finishes. Observations relating to battery involvement included loud popping sounds from the interior of the battery and visible arcing. White smoke and off gassing were observed steadily throughout the test and were consistent with the release of electrolyte material. However, no projectiles, explosions, or bursts were observed during the test while the battery was exposed to the burners, while it was in a free burn state, while it was being suppressed, or after suppression efforts ceased.

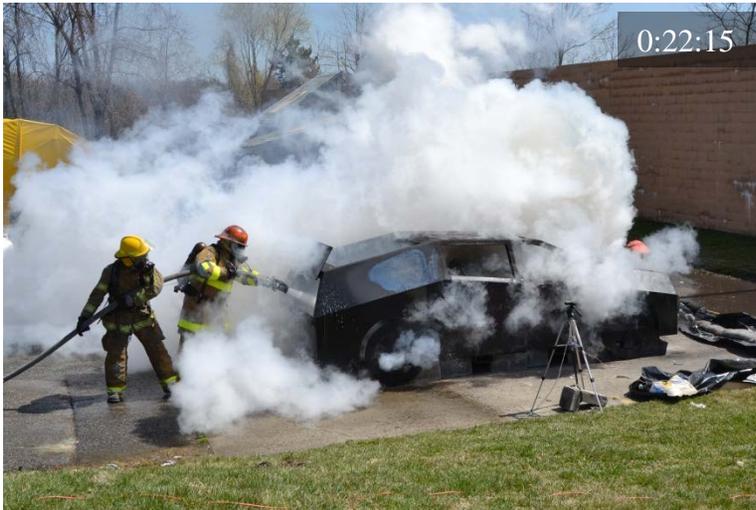
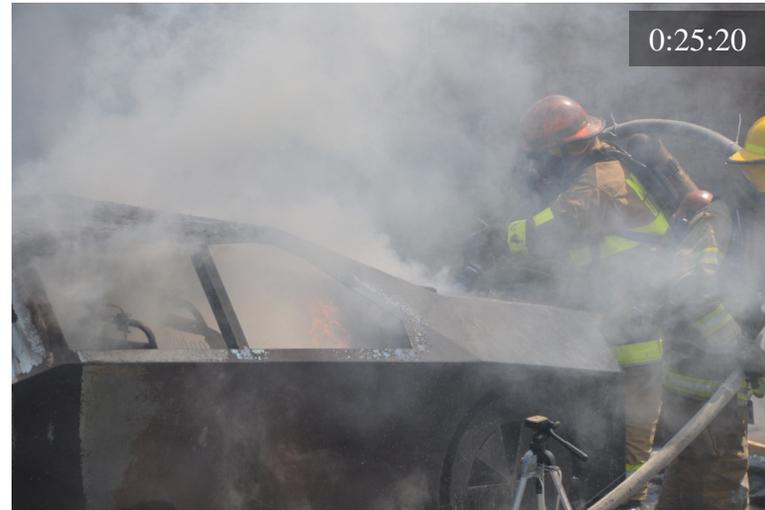
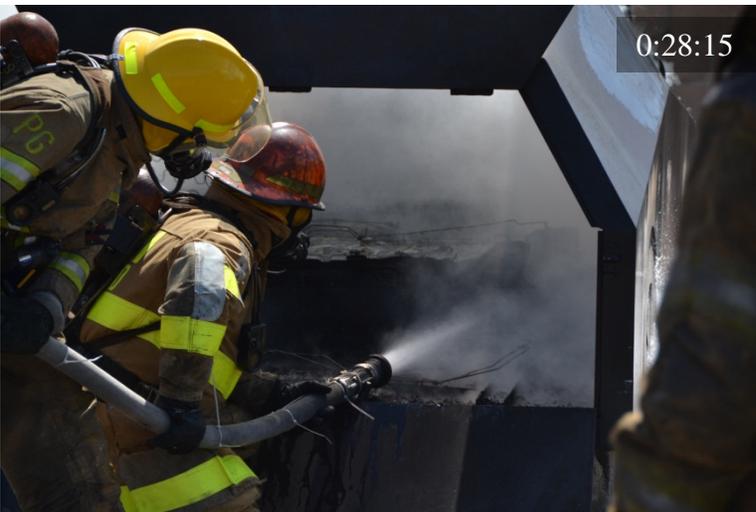
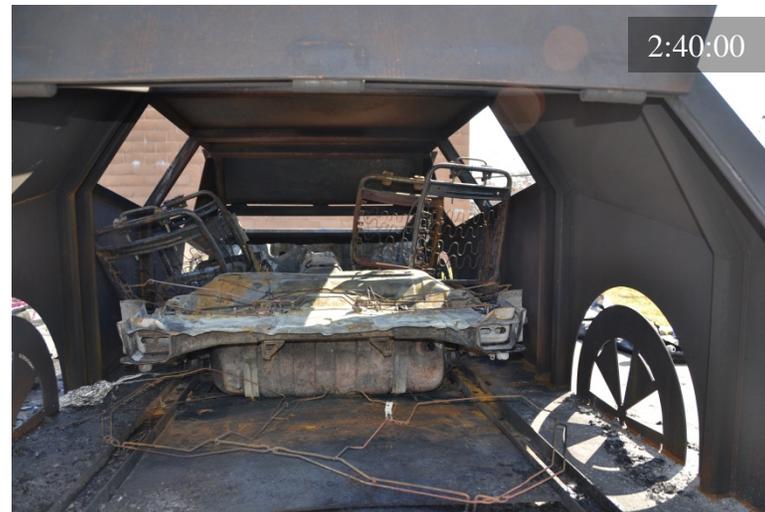
Figure 89 Test B3: suppression starts (top left); reignition and suppression (top right, bottom left); post suppression (bottom right)
