Career Part-Time Fire Fighter Dies After Being Struck by Pressurized SCUBA Cylinder — Ohio

Executive Summary

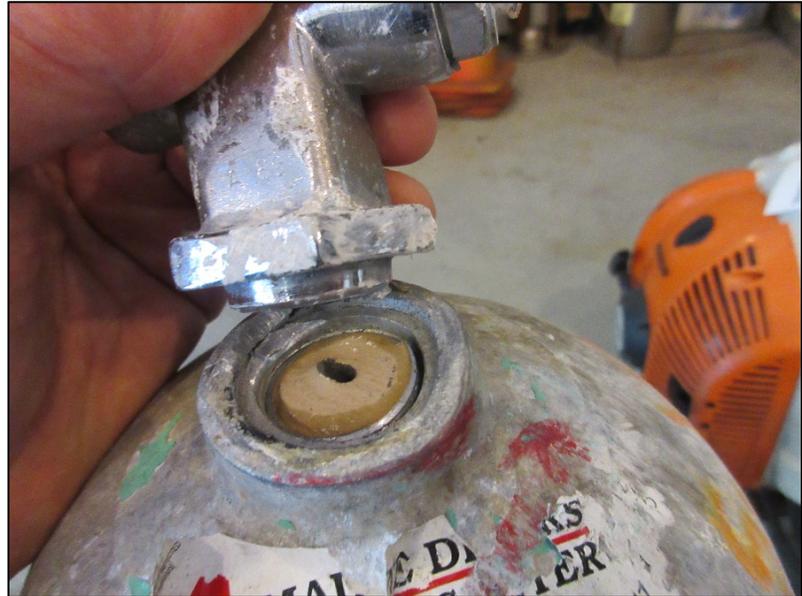
Close-up photo shows broken cylinder valve and neck area of SCUBA cylinder that struck the 33-year old fire fighter. (NIOSH Photo)

As part of the NIOSH investigation, the cylinder valve was sent to an engineering laboratory for a metallurgical analysis to help identify why the cylinder valve was stuck shut. Based upon the laboratory's visual inspection and tests conducted, chloride-induced corrosion was the root cause of the failure of the regulator valve's normal operation. Corrosion locked the regulator valve in the "closed position", and did not prevent compressed gas escaping elsewhere from the valve body at full pressure. See Appendix One for the laboratory conclusions and summary page. The full laboratory investigation report is available upon request.

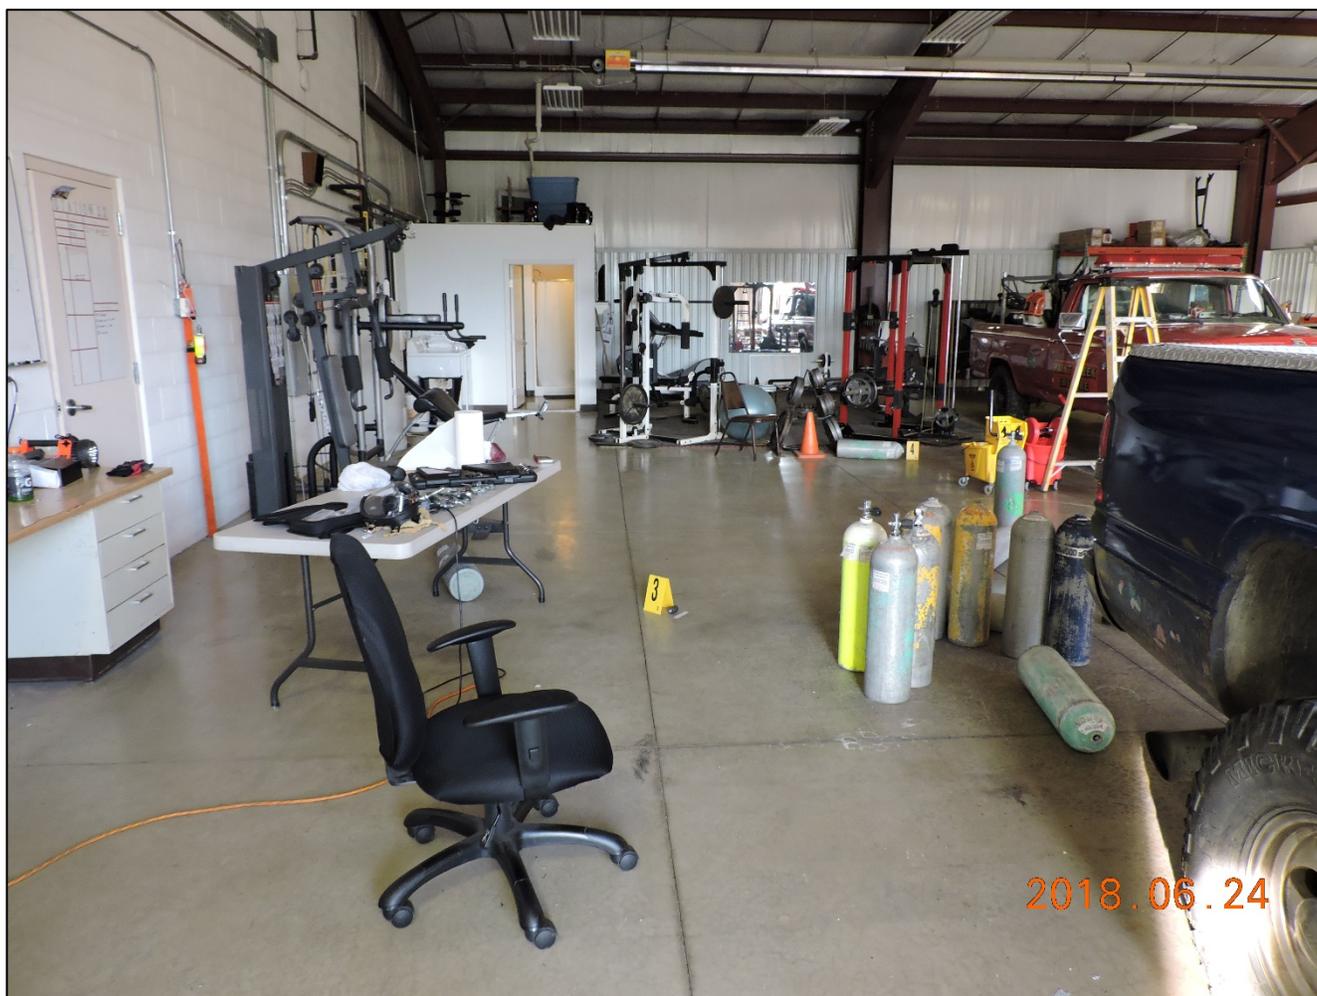
Photo 1: Photo shows the North engine bay at Station 22 where the incident occurred.
Photo courtesy of the State Fire Marshal's Office.

This incident occurred inside the north engine bay at the fire department's Station 22. In addition to existing work benches, fire fighters had set up a table near the Side B wall to hold assorted tools, SCUBA cylinders, and cylinder valves (see Photo 1). The fire fighters were also working on the engine bay floor. The station did not have a cylinder containment vessel or system to contain cylinders.

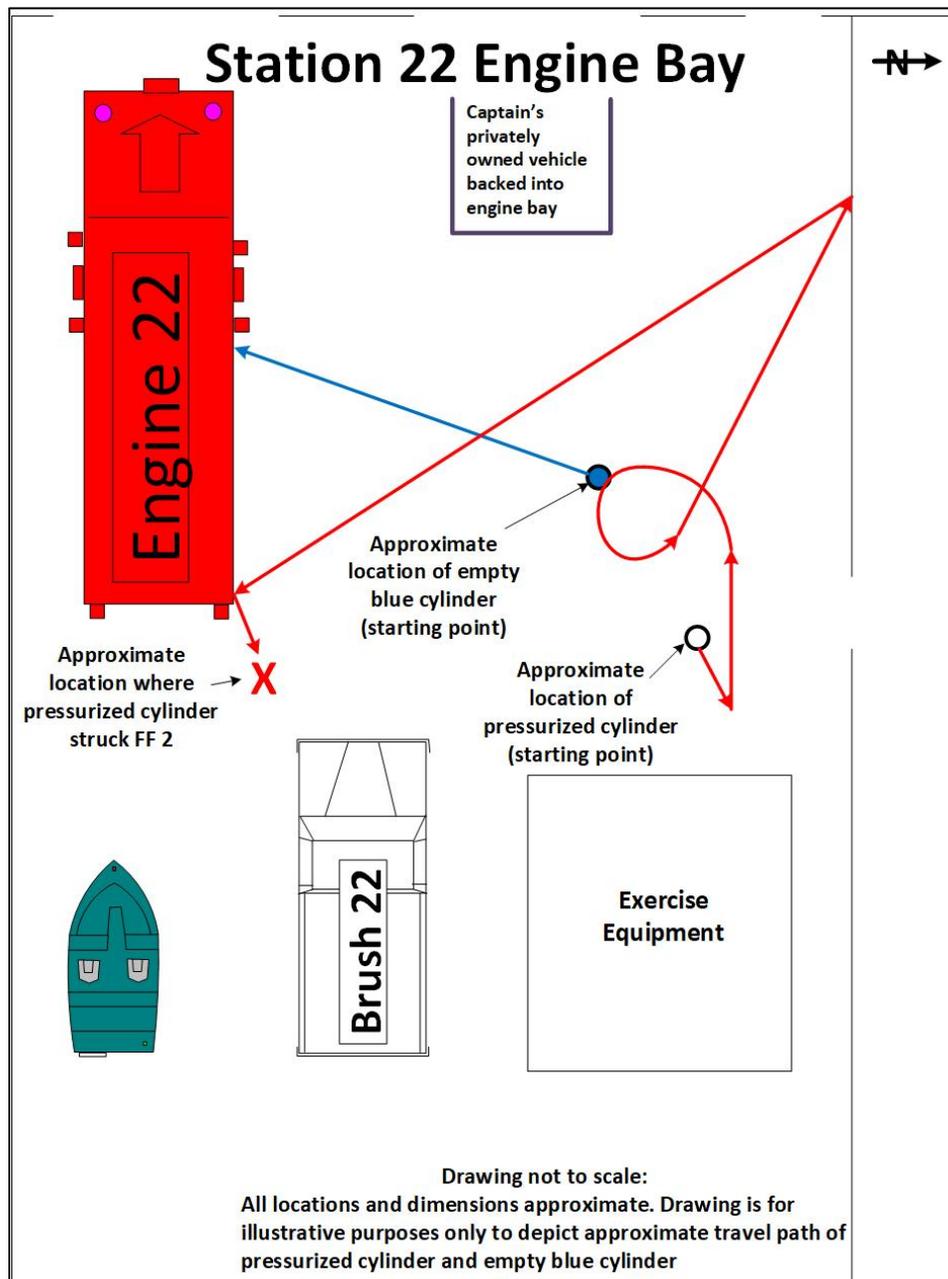
NIOSH Diagram.

Diagram 1. Diagram shows the approximate travel paths of the pressurized SCUBA cylinder and the empty blue cylinder which became airborne after being struck by the unrestrained pressurized cylinder.

struck the passenger side of the engine (see Diagram 1), bounced up toward the ceiling, struck an overhead pipe and came to rest on the engine bay floor.

Photos 8 through 10 as well as Diagram 1 depict the estimated travel path of the airborne pressurized cylinder. State Fire Marshal's Office investigators and local deputy sheriffs investigated the incident scene immediately after the incident and were able to estimate the likely travel path of the cylinder.

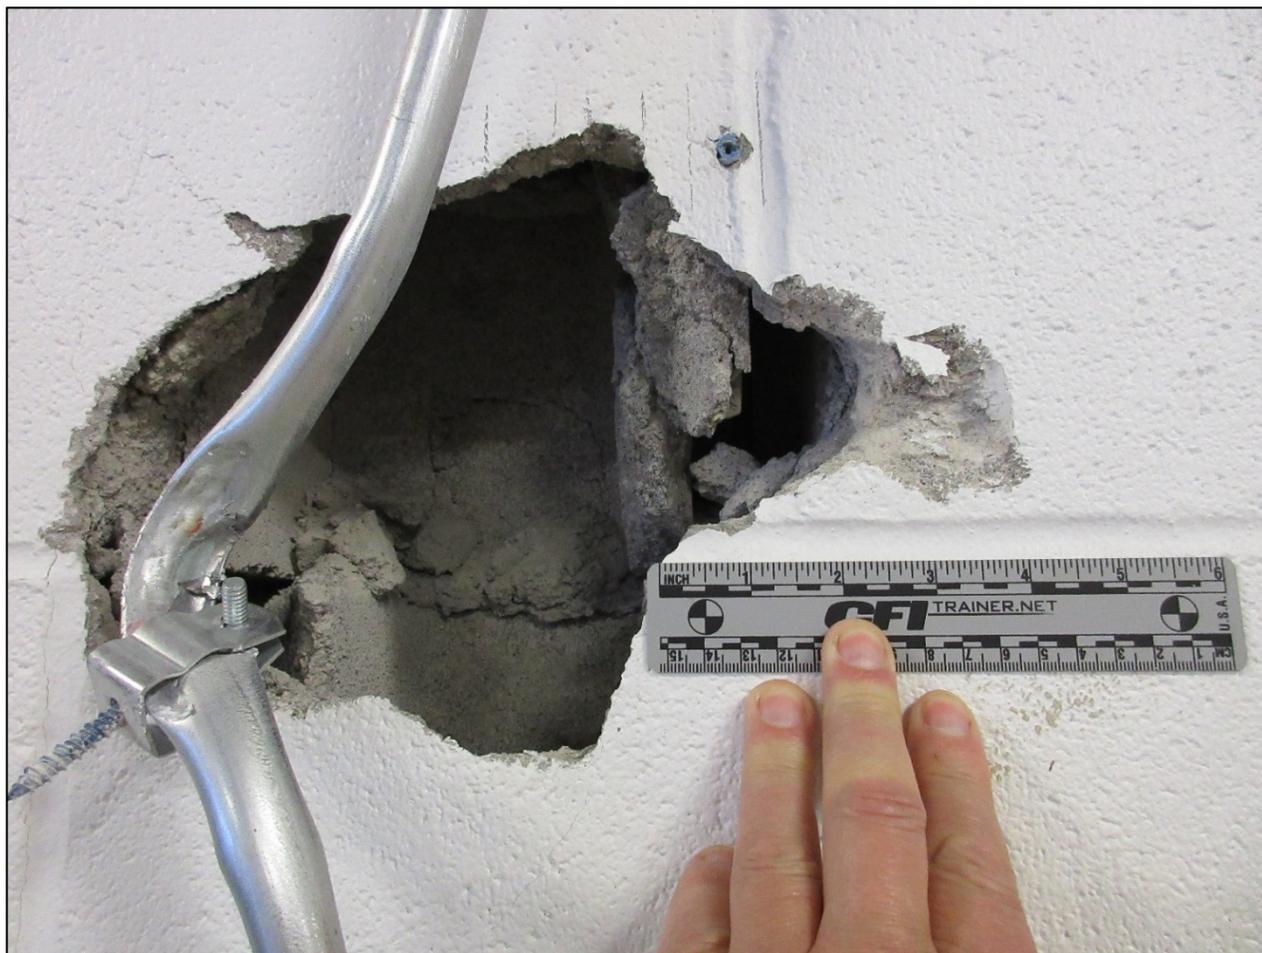
NIOSH Photo.

Photo 2. Hole in engine bay wall caused by SCUBA cylinder (valve end) striking the wall after the cylinder became a projectile.

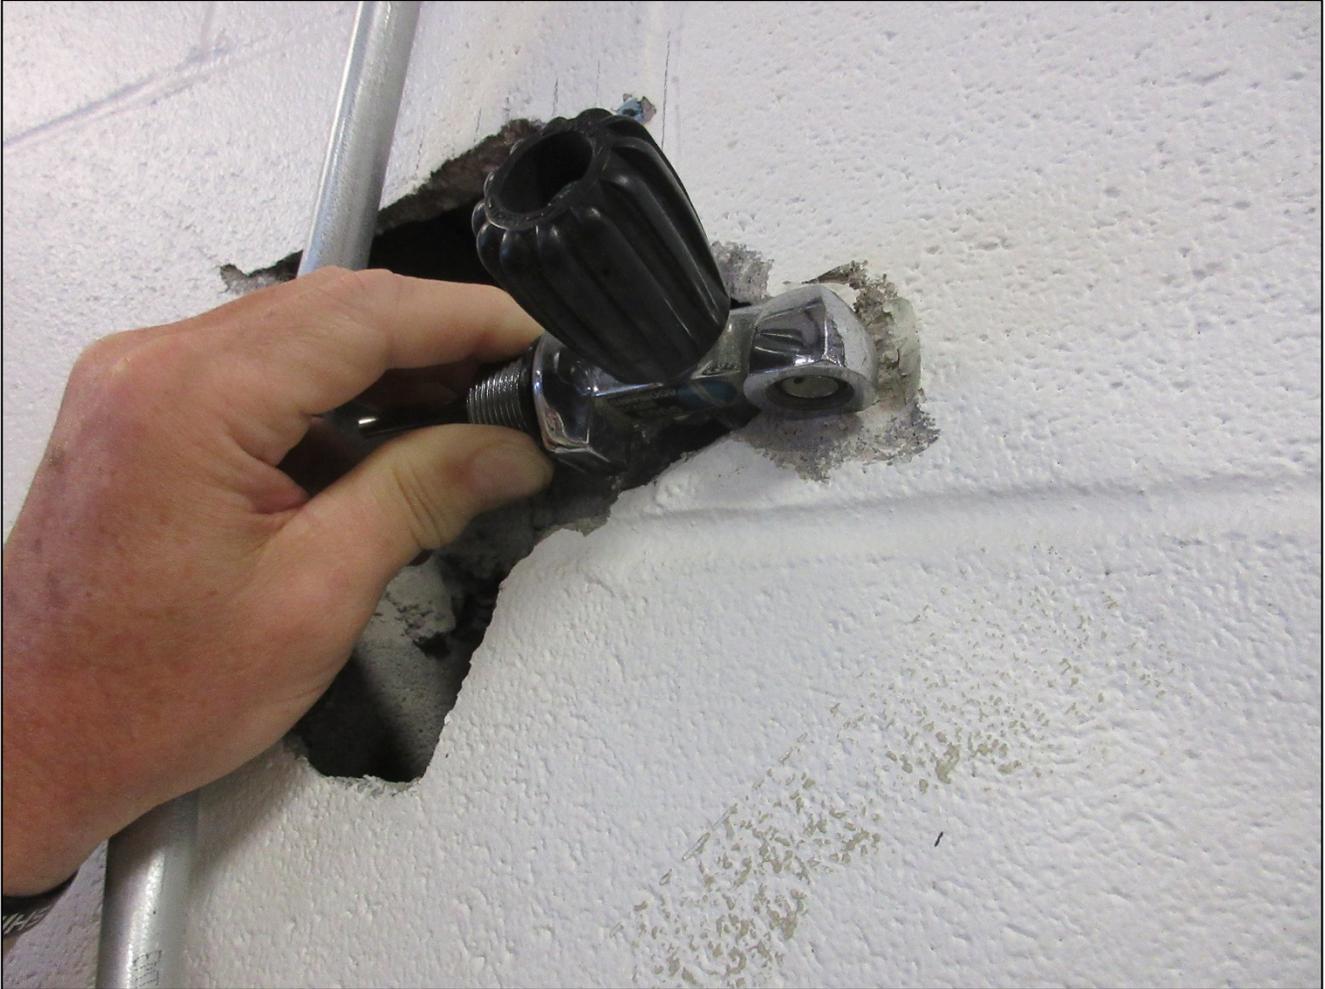
NIOSH Photo.

Photo 3. Exemplar SCUBA cylinder valve is held up against wall where the incident SCUBA cylinder struck the engine bay wall, creating a hole in the wall. Note how the shape of the cylinder valve matches the damaged area on the wall

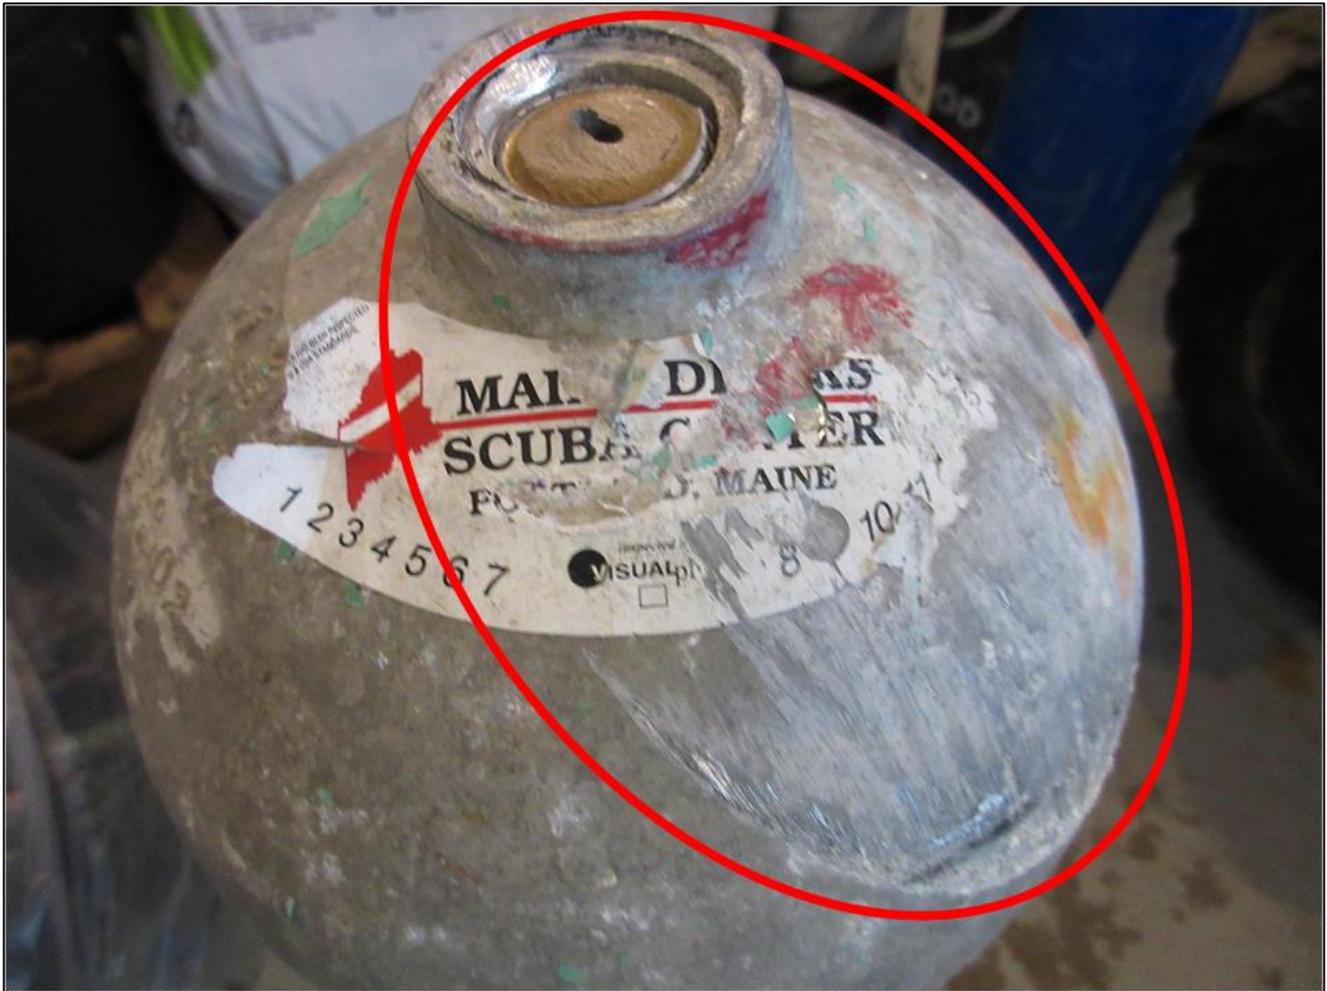
NIOSH Photo.

Photo 4. The SCUBA cylinder involved in this incident. Note the scuff marks on the cylinder caused by the cylinder striking the engine bay wall (see Photo 2 and Photo 3). The area highlighted in red is the area that impacted the wall.

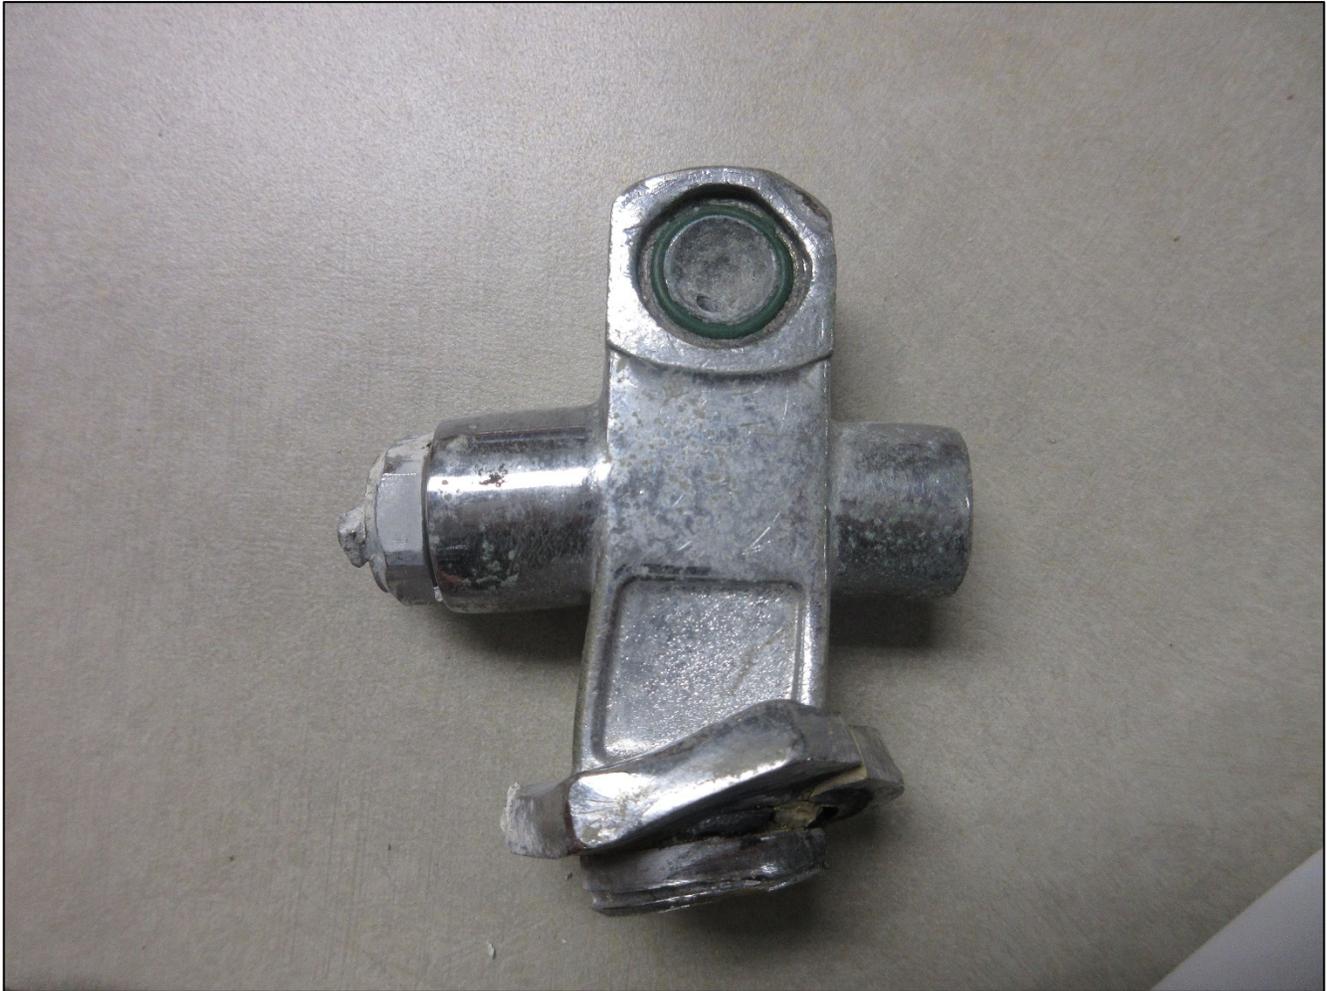
NIOSH Photo.

Photo 5. SCUBA cylinder valve involved in the incident. This cylinder valve was broken off from the SCUBA cylinder when the cylinder struck the engine bay wall. It is believed that the valve handwheel (left side of valve in Photo above) also broke off when the cylinder struck the wall. See Photo 4.

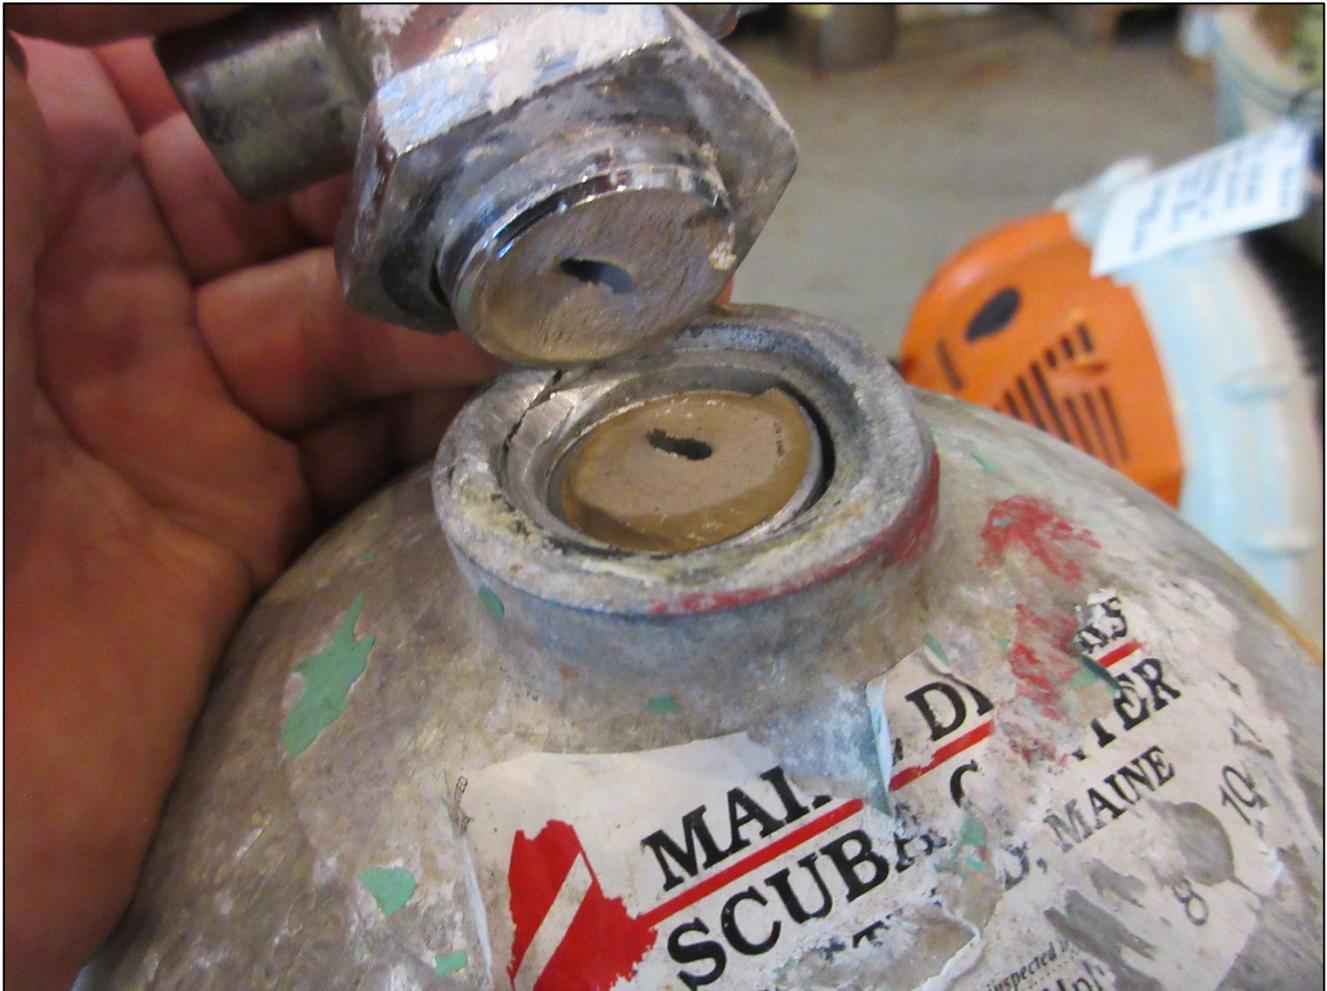
Photo 6. Photo shows how cylinder valve broke off the SCUBA cylinder when the cylinder impacted the engine bay wall. Also see Photo 2, Photo 3 and Photo 4.
NIOSH Photo.

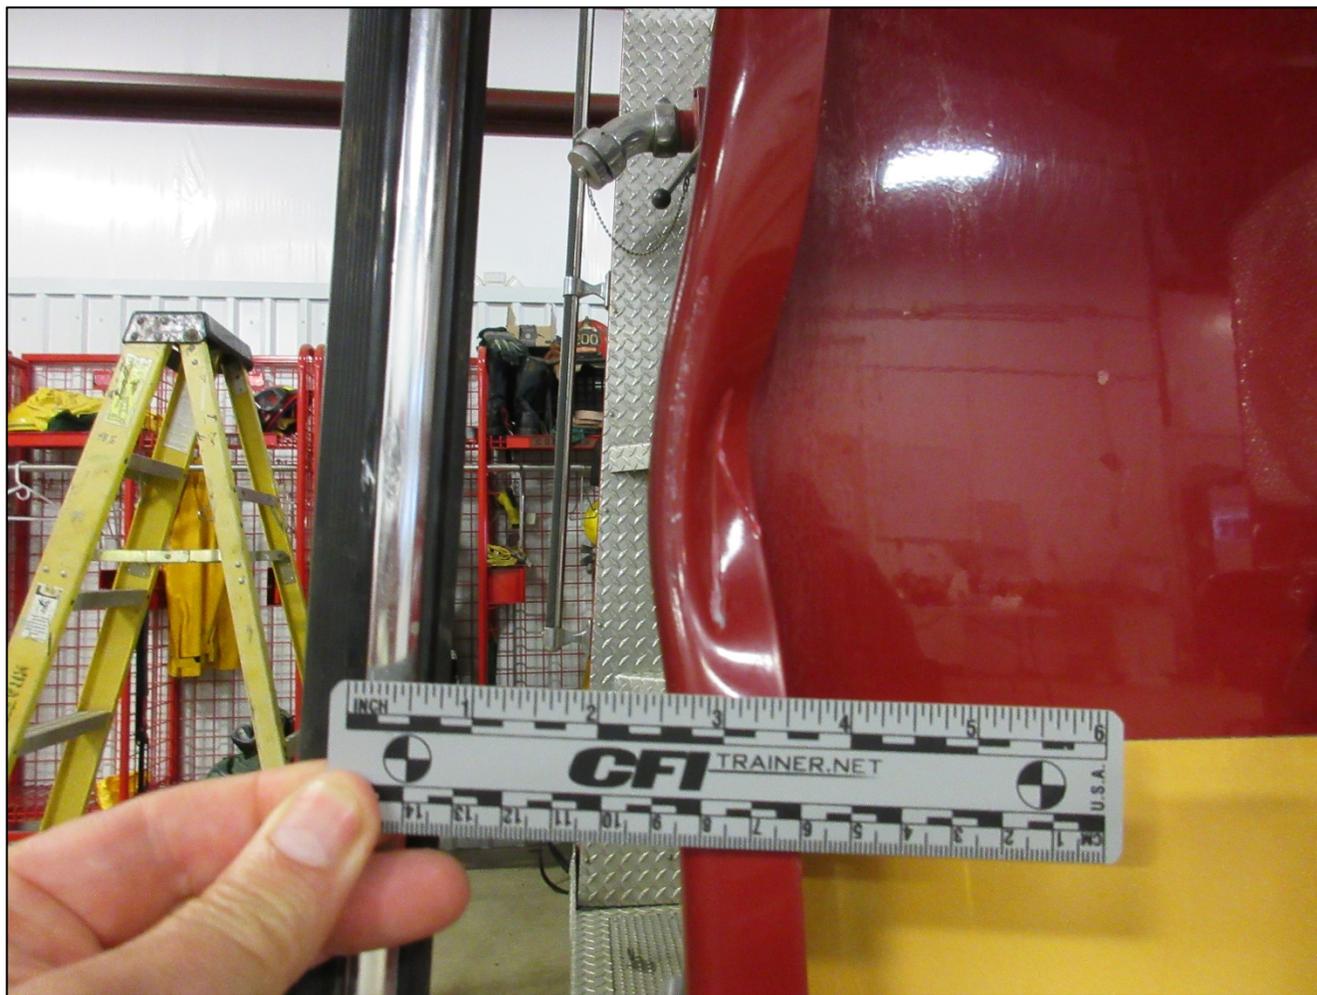
Photo 7. Close-up view of the dent on the rear of Engine 22 (officer side) where the pressurized cylinder struck the engine before glancing off engine and striking Fire Fighter 2.
NIOSH Photo.

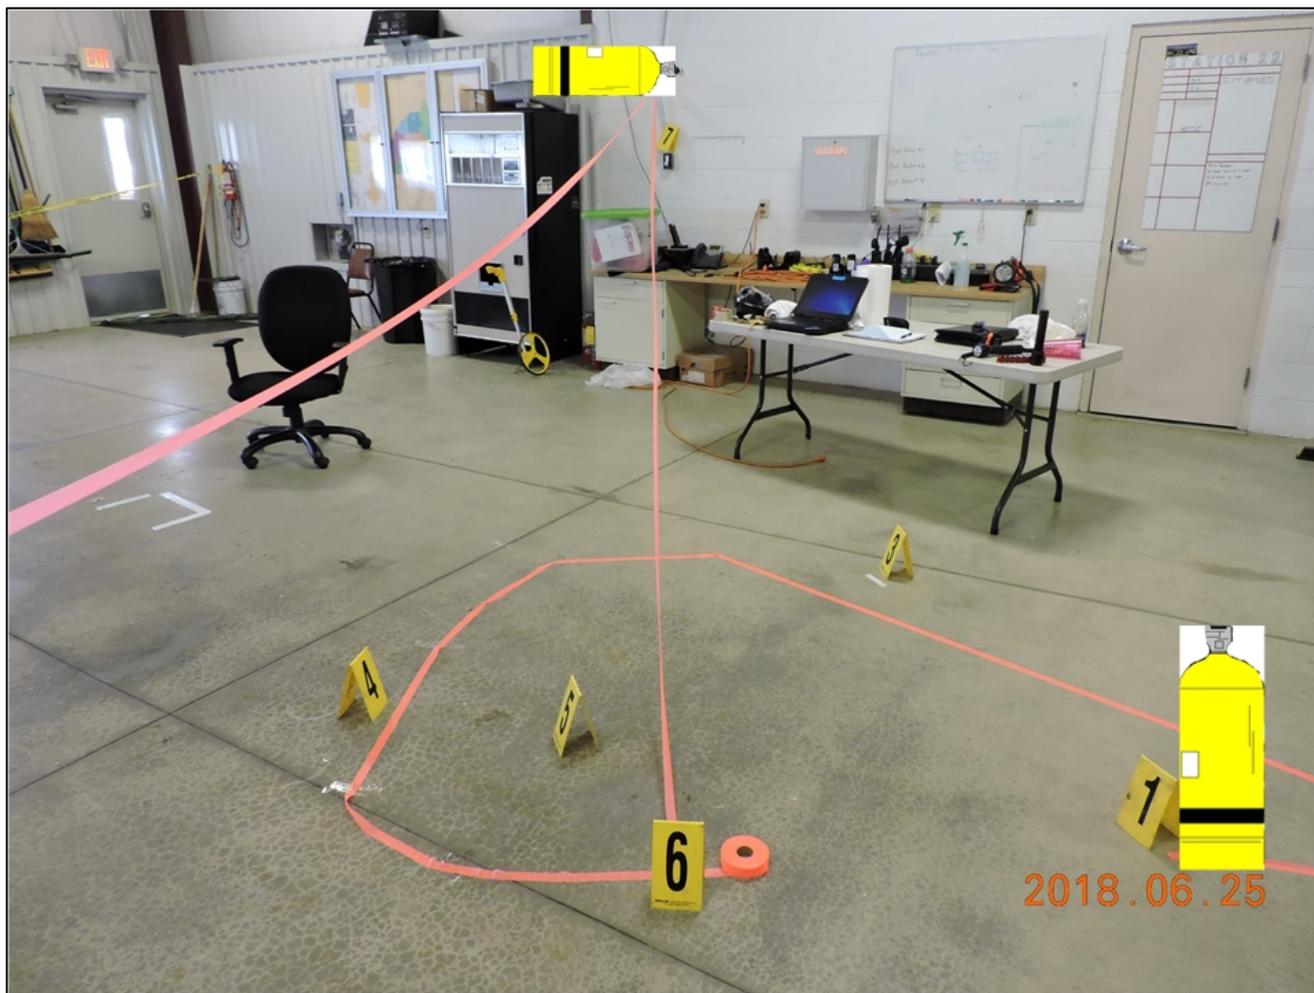
NIOSH graphic using photo supplied by State Fire Marshal's Office.

Photo 8. Photo depicts estimated path of cylinder after compressed air was released through pressure relief burst disc orifice. Cylinder was standing on end at Position 1 when it began to spin and rotate due to the escaping air pressure. The orange tape marks the cylinder's travel path estimated by State Fire Marshal's Office investigators and County Sheriff's Deputies. Cylinder is believed to have become airborne at Position 6 and traveled in a spinning motion until it struck the engine bay wall at Position 7. Also see Photo 9 and Photo 10.

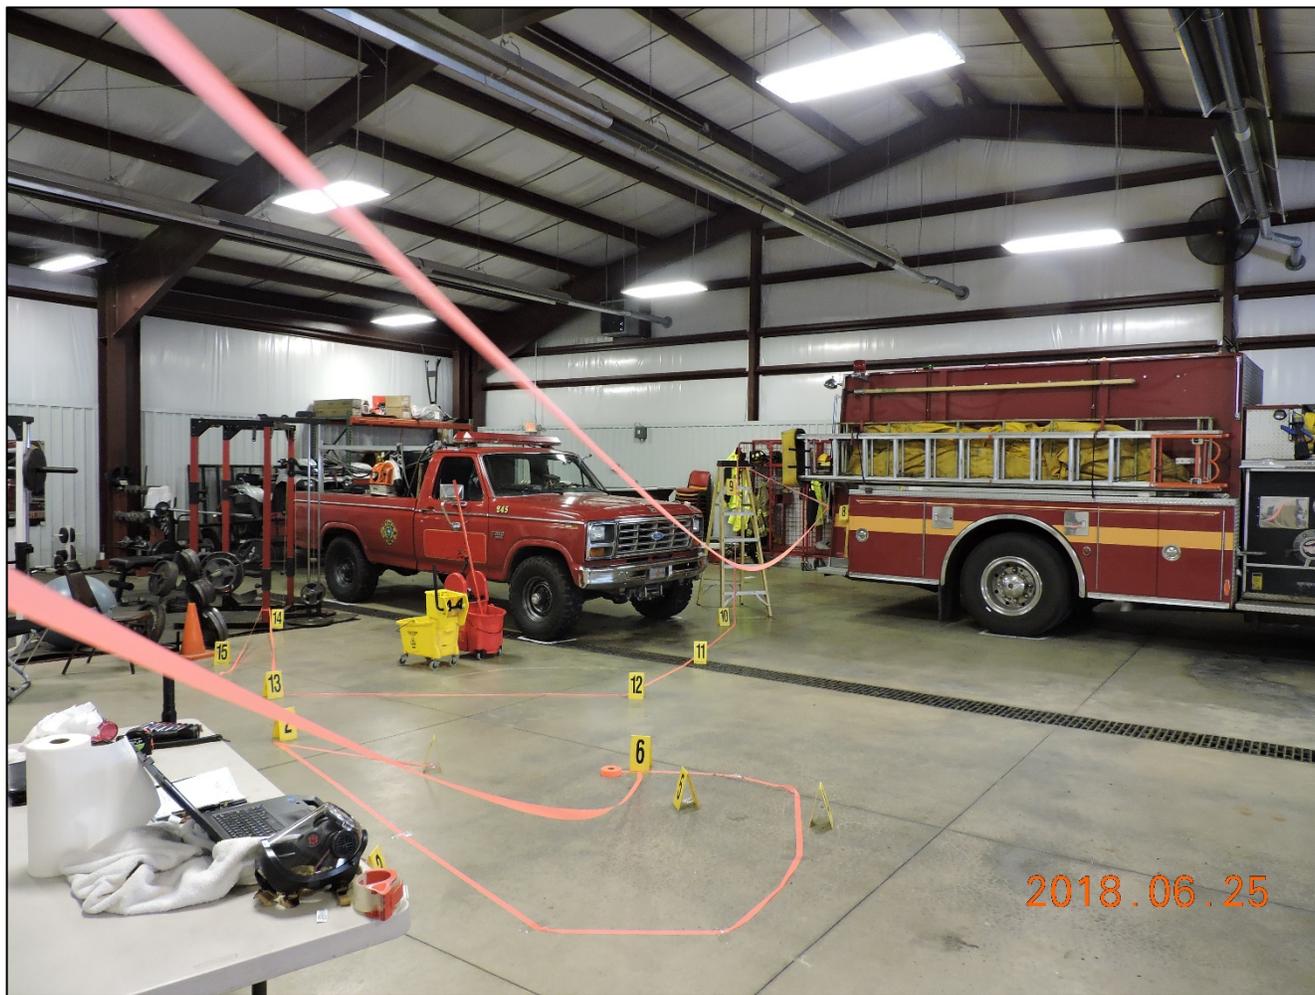
Photo courtesy of State Fire Marshal's Office.

Photo 9. Photo shows estimated travel path (estimated by State Fire Marshal's Office investigators and County Sheriff's Deputies) of the cylinder after it struck wall and the cylinder valve broke off. This caused the air to escape the cylinder at an increased rate. The cylinder bounced off the wall and was projected across the engine bay where the cylinder struck the right rear corner of Engine 22 (Position 8), then struck the Fire Fighter 2. The step ladder at Position 9 marks the approximate location of Fire Fighter 2 who was moving to take cover behind the brush truck. After striking Fire Fighter 2, the SCUBA cylinder fell to the floor and continued moving along the path indicated by the orange tape from Position 10 to Position 15 where the cylinder came to rest near the exercise weight equipment. Also see Photo 8 and Photo 10.

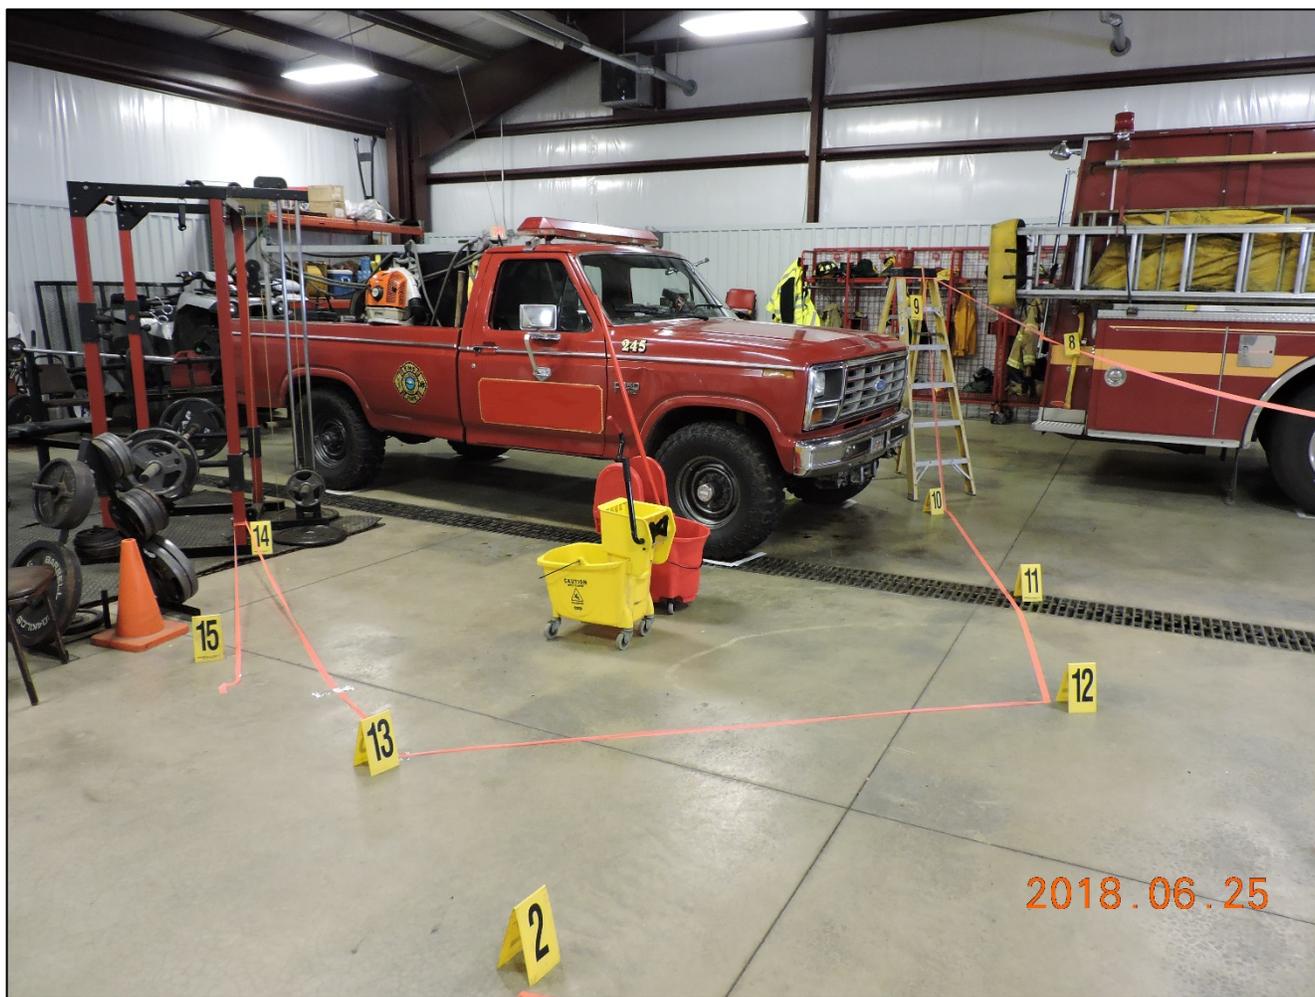
Photo 10. Photo shows estimated travel path (estimated by State Fire Marshal’s Office investigators and County Sheriff’s Deputies) of the cylinder after it struck the rear corner of Engine 22 (point 8), then struck the fire fighter at approximately Point 9 before falling to the engine bay floor (point 10) and expending energy as it moved across the engine bay floor before coming to rest at Point 15 near the exercise weight equipment. Also see Photo 8 and Photo 9.
Photo courtesy of State Fire Marshal’s Office.

Hearing this commotion, the three fire fighters began to move out of the way to find cover. Fire Fighter 1 quickly moved to his left away from the cylinders while the captain and Fire Fighter 2 moved to take cover behind the brush truck parked behind Engine 22 (see Diagram 1). After striking the empty blue SCUBA cylinder, the leaking pressurized SCUBA cylinder was launched in the opposite direction across the engine bay and struck the concrete block wall approximately 7 feet above the floor (see Photo 2 and Photo 3). When the cylinder struck the wall, the cylinder valve was sheared off at the cylinder neck (see Photo 4, Photo 5 and Photo 6). The valve body came to rest on the floor near the man door entrance to the engine bay. The valve hand wheel separated from the valve body and came to rest on the floor near the work bench. The cylinder was then projected at an angle back across the engine bay where it struck the rear corner (passenger side) of Engine 22 before glancing off the engine and striking Fire Fighter 2 in the head (see Photo 7 and Diagram 1). The cylinder landed on the engine bay floor and continued to expend energy as the remaining air was depleted, before coming to rest near exercise equipment located at the rear of the engine bay (see Photo 10).
